EAA® Technical Counselor News

APRIL/MAY '88

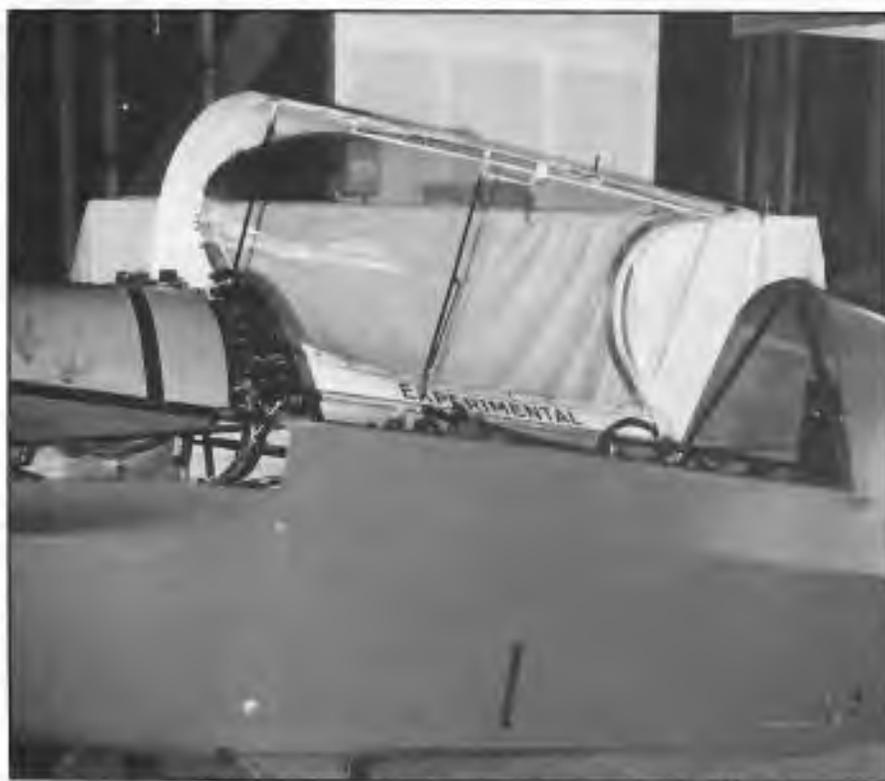
Arrow indicates where the trouble was, only on the other side of the aircraft.

I purchased a fuel tank from John Monnett's operation a few years back that was supposed to have been pressure tested, etc. after welding. While waiting for the tower to clear me for high speed taxi, I smelled gas and promptly shut down to return to the hangar. I had trouble finding the leak until I pulled off the cowling, and there I discovered a 6 inch length of welded seam right along the longeron was leaking rather badly. It appeared to be along the very edge of the weld. I drained the tank, pulled it out and on close inspection, found the welds to be cracked down the middle and also found evidence of leaching at the front and bottom of the tank. None of the outlet bosses leaked. Prior to this day, it had only kept about 4 or 5 gallons of gas in it, and this day I had filled it up expecting to fly in case of necessity, but was only planning a high speed taxi or short lift off. I wanted a full tank in case I went around. I can't help but feel that this could have been a real disaster had that seam opened very much more. I would heartily recommend all Soneral owners with the tanks purchased from Monnett to inspect the seams along the longeron and also the front and rear bottom seals, as well.
