EAA. Technical Counselor News

DEC. 1988/JAN. 1989

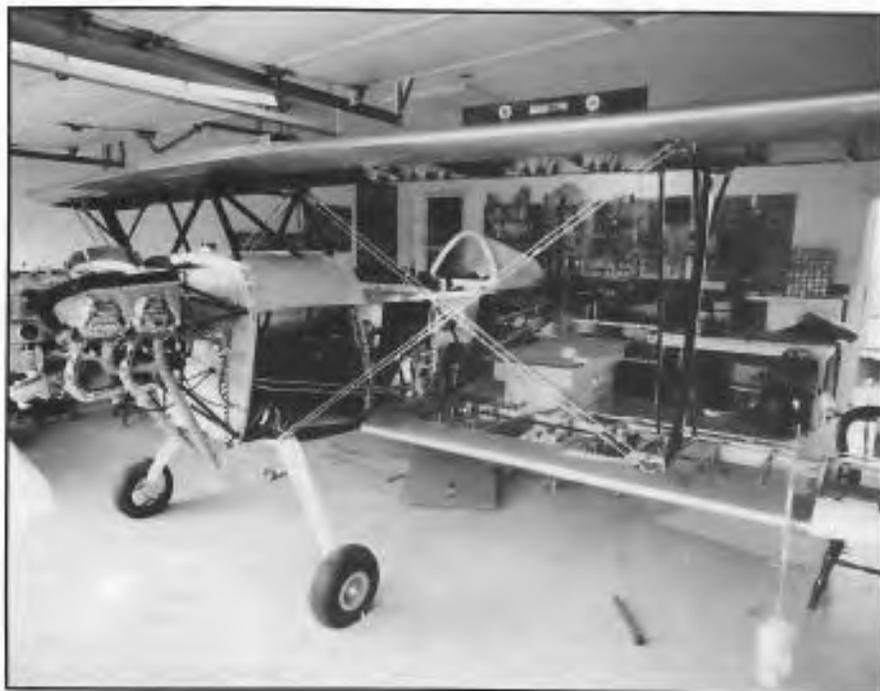
STEVE HILL'S CHRISTIAN EAGLE II

Technical Counselor Bob Sloe reports that the aircraft has excellent workmanship and is ready to cover. They did a general inspection prior to the cover of the airplane. Steve lives in Liberty, Kentucky.

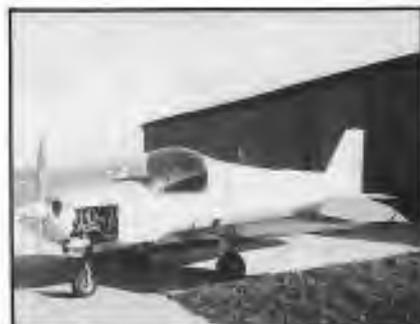
Bud Shanks reports on Carl Frederick's Zenith CH200. First flight was 6/20/88, building time ten years. Good building job.

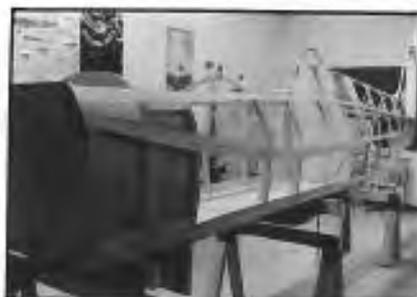
This view of the left side shows an additional longitudinal member presumably for the hinged on door. The workmanship is above average and the material used is the same. Russian plywood is available in Canada and it looks very good.

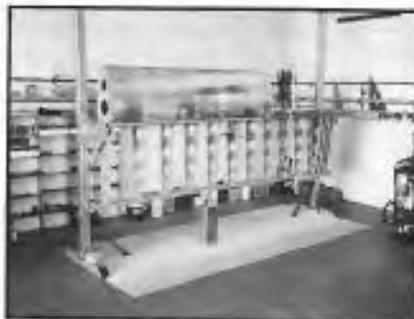
This shows the wing in the jig and the extensive use of rugs etc. to keep it from getting scratched.

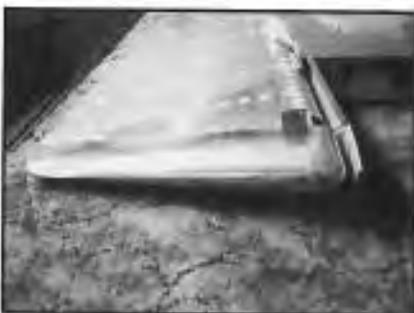
This shows the bottom of the rudder. To keep from scratching aluminum, use of a lot of rugs, and in this case, tape to keep from scratching around the rivet holes when it is held together with clecos.

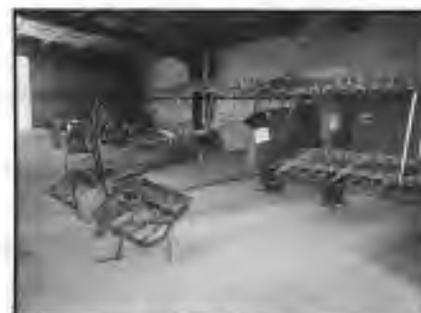
TOLEDO SE5A

This aircraft is being built by Marlon Robles of Lakeland, Florida. Technical Counselor Larry Russell reports the aircraft is now rigged for display with non aircraft hardware and will be corrected before flight. Russ has not yet decided for sure as to what engine he will have for the aircraft. Note the rebel flag for the tail!
