EAA[®] Technical Counselor News

DECEMBER/JANUARY, 1987

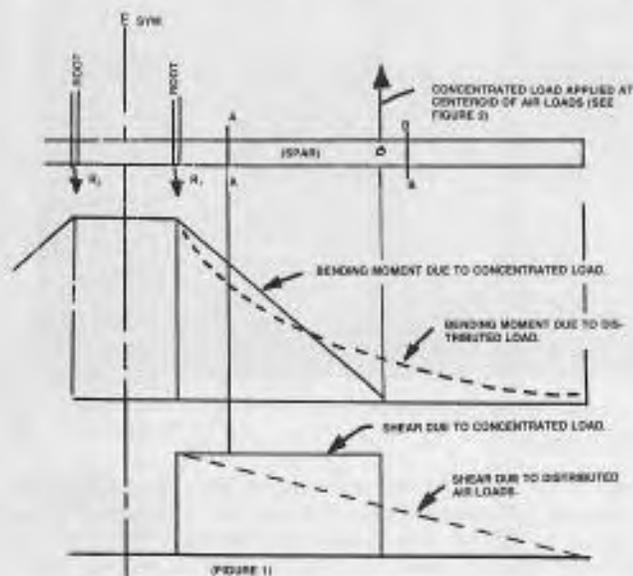
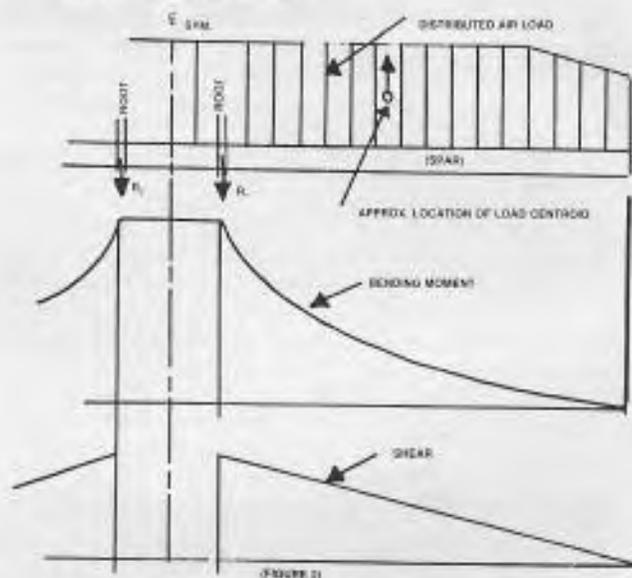
- 1) The only point where bending and shear are the same as induced by a distributed load is at the root.
- 2) At a section A-A, the bending moment due to a concentrated load is higher than the bending moment due to distributed load. Therefore, the caps will be overloaded.
- 3) At a section B-B, there is no bending or shear. If the caps and web are tapered, there may be a weak spot and since it is not tested, how do we know it is any good?
- 4) You can see that the shear immediately inboard of the concentrated load could be as much as twice the shear due to distributed load, and that may fail the shear web, because there is too much load.

The write-up in the magazine indicates a premature failure of the cover cap (in tension?). This is rather unique. The failure was at about half of the design load? 425 lbs. in lieu of 800 lbs. Something is very fishy. Hard to believe that "too dry wood" will fail at 50 percent or less of calculated load. I

I may add that it seems that the spar cap failed at approximately the root, and that is the ONLY point where a distributed air load or a concentrated test load yield same bending moments and shear. So by great coincidence, we may say that this test is valid to simulate loads at this critical section. Hope I did not make it too complicated.

Anyway, to design ANY light airplane to 3g load (I assume limit load) is (may I say) criminal. In my book, I would design to +6g (LIMIT) and it does not need to be an aerobatic airplane. I like to see the +6g's just to avoid this type of surprise.

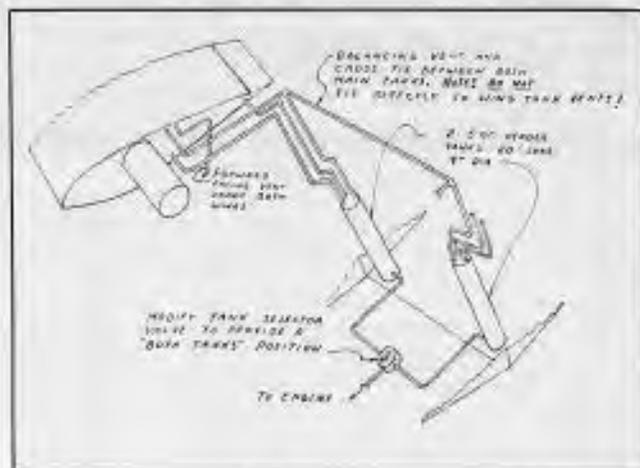
BD-4 FUEL FLOW PROBLEM

This arrangement appears prone to experience fuel flow problems with anything less than a full fuel load, because one port can be uncovered during high angle of attack operations. The uncovered port then allows air to enter the line, near the selector valve, and reach the carburetor or fuel pump, resulting in complete power loss.

Secondly, the lack of a "both" position at the fuel selector valve subjects the aircraft to total loss of fuel flow in a slightly uncoordinated or climbing turn, if fuel is being drawn from the tank in the lower wing.

The obvious solution for the fuel selector valve is to modify it to provide a "both tanks" position, or, alternately, to obtain a valve incorporating this provision. It is also important to placard the aircraft for use of the "both tanks" position during takeoff and landing operations.

On the specific aircraft that was the basis of this article, the unported tank outlets that occur during high or low angle of attack operations were accommodated by installing a pair of 5 quart header tanks behind the rear seat. Each wing tank port feeds directly into the associated header tank via an individual 3/8 inch minimum diameter line. Each tank port is protected by a finger strainer. A balancing line to each header tank was installed. This is absolutely necessary to avoid an air locked condition and insure rapid refill of the header tank when normal aircraft attitude is resumed. The normal main tank vents must not be directly connected to this balancing line.

The header tanks were constructed of 20 inch lengths of 4 inch diameter 6061-T6 tube with .050 inch walls. The tanks were located vertically, just aft of the rear seat with the lower end secured to the aircraft's lower skin via the drain valve fitting. The upper end was secured to the seatback frame. Fuel is fed to the selector valve at a point one inch above the bottom of each tank. This provides a sump for water collection and removal. The general arrangement is as shown in the drawing. Total empty weight addition was approximately 4 lbs. for both the header tanks and the additional lines.

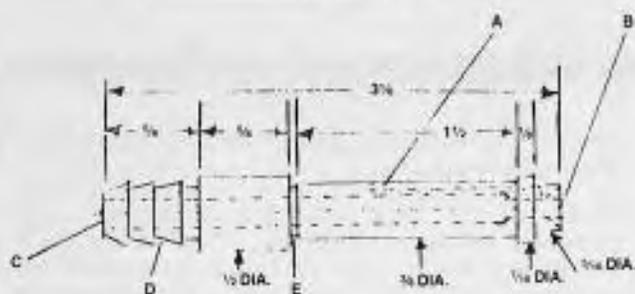
One Piece Main Jet for 32mm Posa

- A Key seat $\frac{1}{16}$ " deep x $\frac{3}{16}$ " wide x 1" long.
- B Duplicate bell mouth as on original main jet. Maintain relation with A.
- C Main jet orifice is reamed $\frac{1}{16}$ " x $\frac{1}{16}$ " long at outlet. Remainder is drilled $\frac{1}{16}$ ".
- D Barb fitting for $\frac{1}{16}$ " hose.
- E Groove for snap ring $\frac{1}{16}$ " wide $\frac{1}{16}$ " diameter.

Rex reports, "I don't see any negative aspects of doing what Neil Sidders has done, and indeed as he says, the one piece main jet that he's got is an improvement over the four piece assembly. There are some real problems in trying to retro-fit it in the Posa carburetors, however. Since the carburetors are built in a dye cast housing, the piece of the vinyl tubing allows the female side of the metering orifice to line up with the male needle.

"If you were to go to Neil's one-piece female orifice assembly, you'd have to very carefully set up the alignment on the carburetor and jig bore a hole precisely in line with the male needle to capture his one piece female orifice. Even then, I suspect that it wouldn't be a thing that would be repetitive, time after time, because I am well aware of the tolerances involved on these things and the many things that have to be kept under control if the carburetor is going to work.

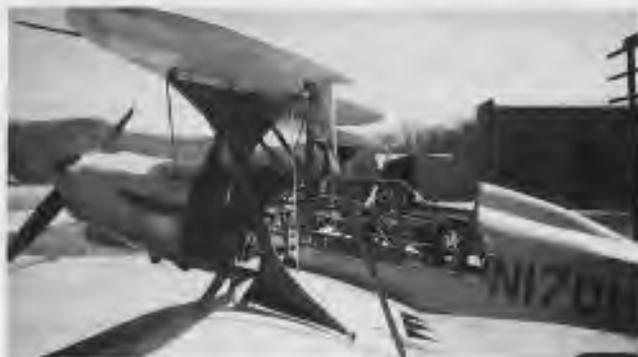
STARDUSTER TOO PROBLEM

We had a problem with a Starduster Too when a party leaned on the ailerons on the ground and found they went to the locked position. Please see the photograph. The service difficulty states, "The ailerons locked in the full deflect position due to absence of a suitable stop at the control surface. This condition was found quite by accident. The submitter stated that maneuvers such as tail slides, hammerhead stalls and wind turbulence might bring about this condition. The Stolp Starduster Corporation, Bill Clouse, President, has taken quick action on this and sent a drawing out for control surface stops on the aircraft. If you have a Starduster Too builder or flier in your area, you should have them contact Stolp Starduster Corporation, 4301 Twining, Riverside, CA 92509, telephone (714) 686-7943.
