DESIGNEE NEWSLETTER

THE PUBLICATION OF THE EAA DESIGNEE PROGRAM

Volume 13, Number 10 October 1982

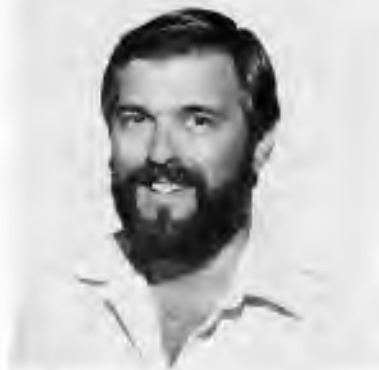
**Peter M. Friedman, Designee 1071
4206 Glencoe Avenue
Venice, California 90291**

Peter has a masters degree in Aviation Safety Management, is an FAA Accident Prevention Counselor and holds FAA A & P and IA licenses. His flying certifications include commercial, instrument, ASMEI, CFII and the Advanced Ground Instructor, Instrument license.
