# EAA. Technical Counselor News

APRIL/MAY 1989

# Photo Gallery

# Technical Tips

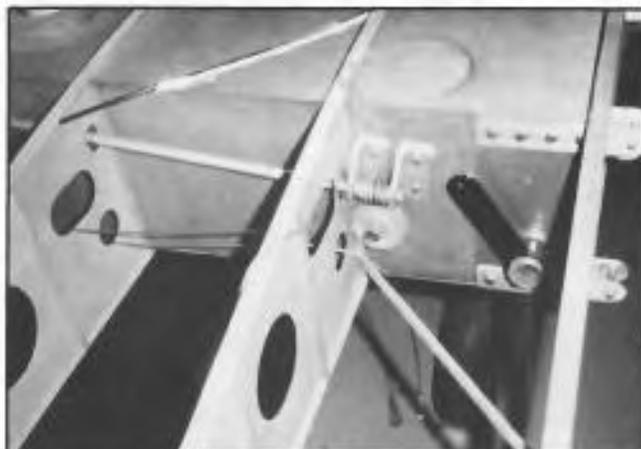
Detail in the area of the wheel retraction mechanism.

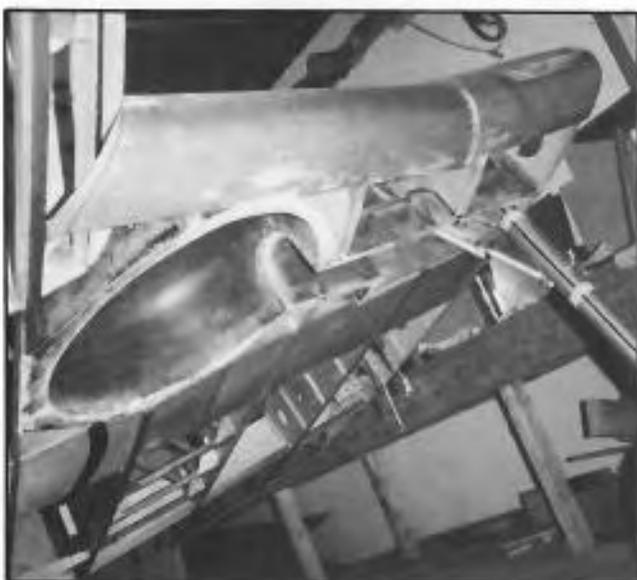
The gear retracts into fiberglass wheel wells made on wood molds Vic built himself.

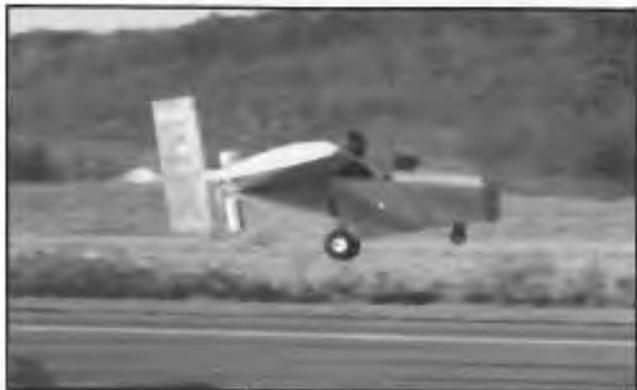
Empty weight — 227 pounds  
Wing Area — 98 square feet  
Fuel Capacity — 1.3 gallons  
Airfoil — modified NACA M-6  
Max. Velocity — 43 mph  
Rotate — 35 mph  
Land — near 28 mph

The present ugly landing gear is just temporary. I started out with an enclosed, central gear without riggers, but like Al Backstrom, got the axle too far aft of the c.g. A redesign of the interior will find the gear back where it belongs. A bubble canopy would help tremendously. Again, thank you for your assistance." Yours truly, Lewis

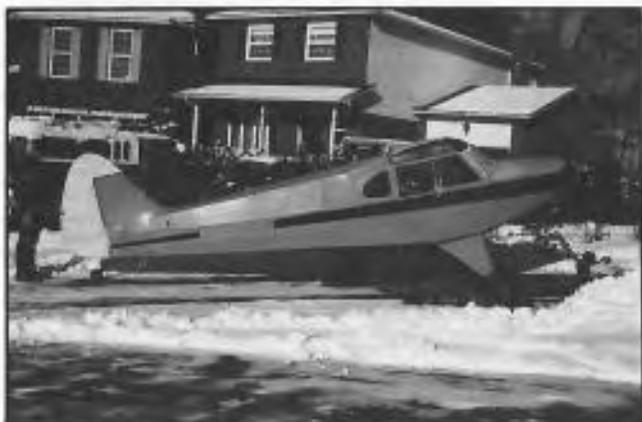
Showing the side view. The main landing gear legs are about 3 inches longer and a little closer together so the aircraft sits higher from the ground. The panel behind the rear window gives access to the battery mounted on the lower longerons and also gives good access to the interior of the fuselage. I am still looking for a larger tailwheel at a reasonable price. Hope to have skis on it and then floats!

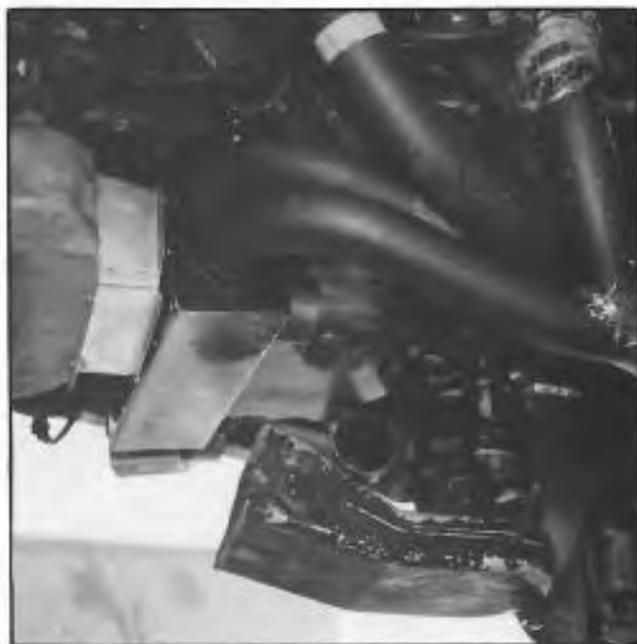
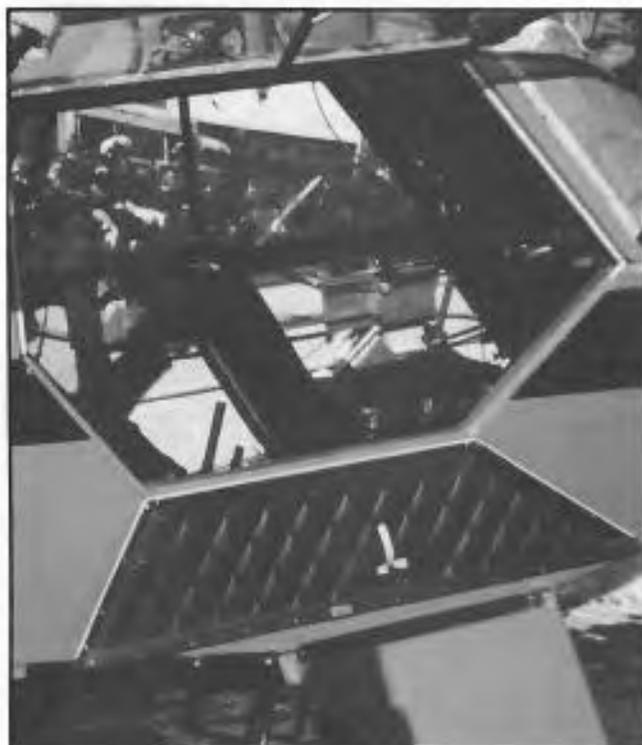
Main heat exchanger. Air first goes through the oil cooler. The exhaust pipe with the rope is only temporary to jig it with polyester resin so I can take it off the engine to make a jig and then cut and reweld. The parallel exhaust tubes running inside the heat exchanger are mild steel automotive, but the rest is stainless.

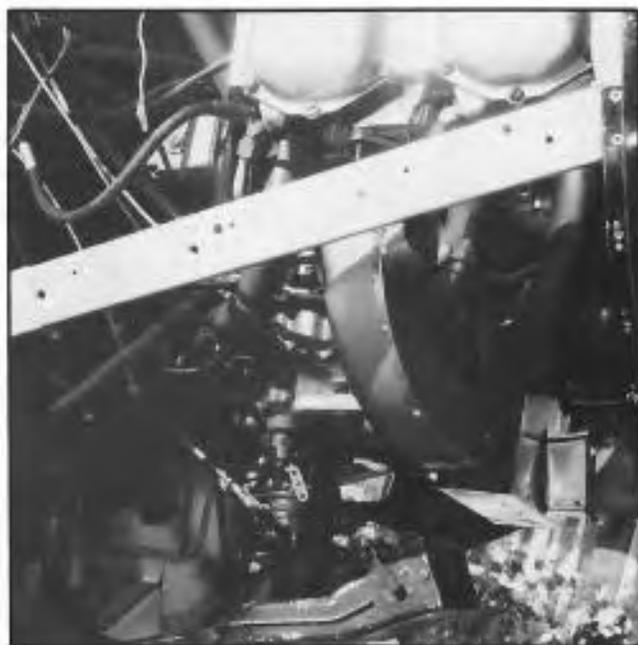
No. 2 heat exchanger for cabin is made of stainless steel. The engine is a Lycoming O-320 (150 hp) from a twin Apache swinging a Hartzell constant speed HC82XL2C propeller. He made the nose bowl.

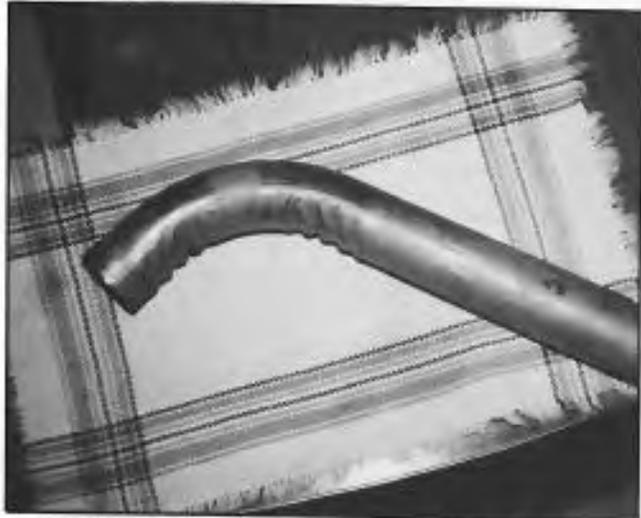
Beautiful wrinkles in our homemade exhaust system.

Regarding bending tubing. I would like to try it. However, I tried a similar method with sand (i.e. plug both ends, leave a threaded hole in one end, keep tapping and adding sand again and again — sounds good, finally screw in the bolt to the threaded hole. I took it to a welding muffler shop where they bent it — the photo shows the result. Beautiful wrinkles, perfectly shaped and symmetrical as you can see in the photo. In the event I cut out the wrinkles and had a patch welded in (see photo).

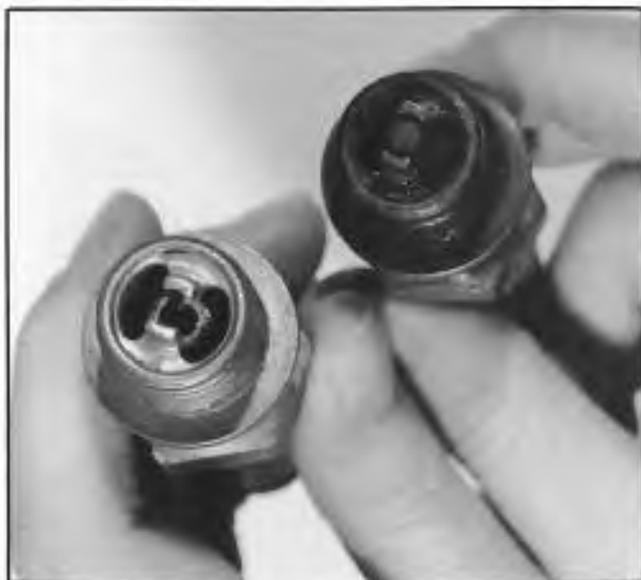
Plugs graphically demonstrate what can happen to jugs in normal usage. The one on the right has had the center electrode blown completely out. The one on the left has a loose center electrode that is sliding back and forth.

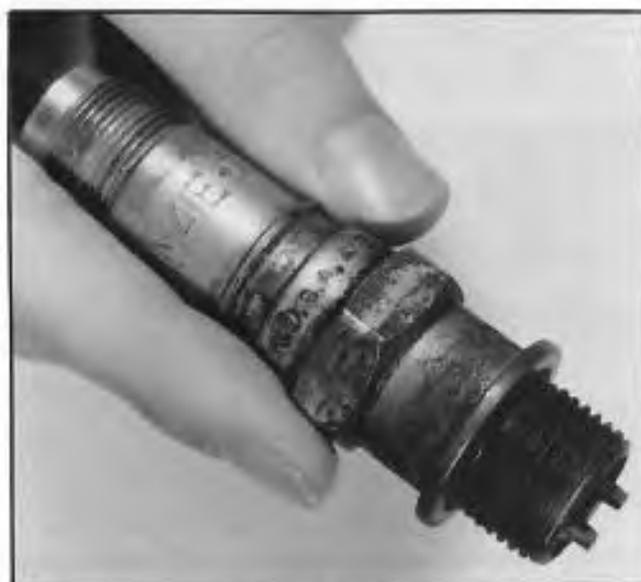
This shows the electrode the way it is slipped down into the core. A slight blow by past the plug on one cylinder can cause a rough running engine and it is very difficult to locate the cause.

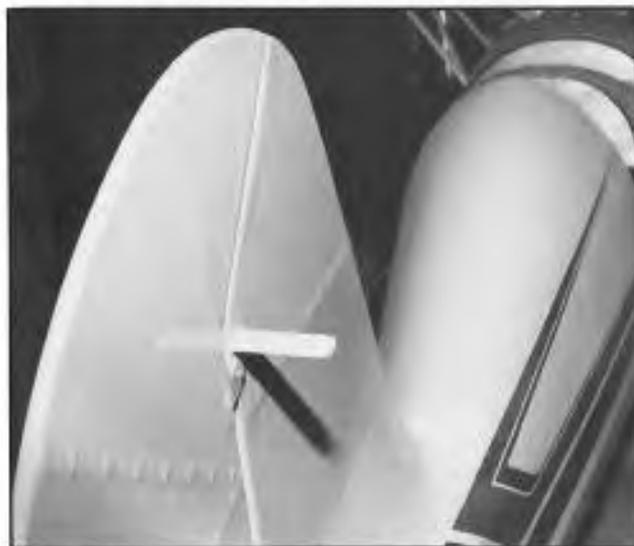
Technical Counselor Glenn Tuttle, 682 West 3800 South, Bountiful, Utah 84010-8425. This is a design that Bob Barney came up with after his first Starduster I was completed and he was building his second Starduster I. In moving his plane around, Bob did not like the idea of having to push or pull on the streamline wires of the tail group. So he came up with the design of welding a piece of streamline tubing (about 8 inches long) onto the vertical stabilizer rear spar. It was welded so that about 3-1/2 inches protruded out from each side of the stabilizer spar, then pinched down (tapered) and rounded off on the ends and then welded closed. The normal filing and sanding will finish it off. This makes a great handle to move your biplane around with and it's very easy to install on an already completed aircraft, particularly if you have access to a heliarc welder.

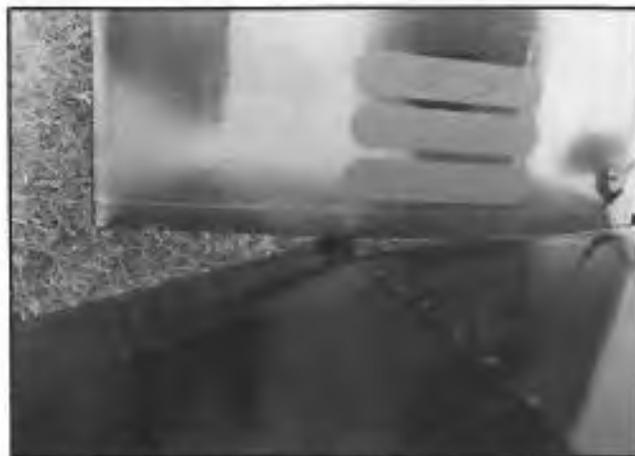
This unidentified biplane at the Oshkosh convention has a great need for a filler strip between the fuselage and wing. As there is always high pressure on the bottom of the wing and low pressure on the top, this tends to go through any cracks and reduce the effective wing span. A slot as great as this one will reduce the effective span right in half.

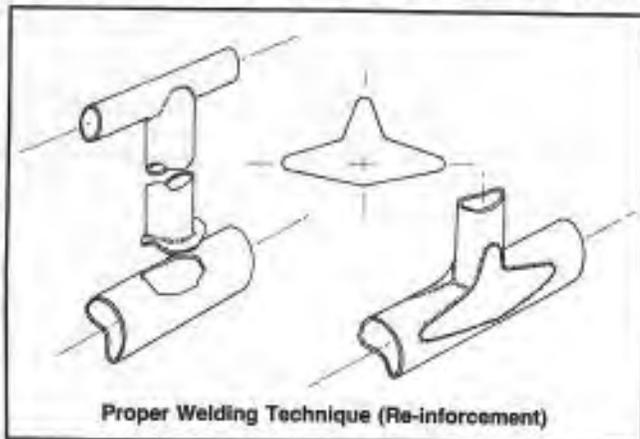
Proper Welding Technique (Re-inforcement)

Ralph reports he is currently operating a Wittman Tailwind W-8. (The second one he's built.) The first problem he had involved a rudder pedal failure and was the second failure experienced on the second Tailwind. The rudder attach pedal broke near the conclusion of a cross country flight. The pilot attempted to stretch his legs to sharpen up for the approach and landing, reared back in the seat, pushed hard with both feet against the rudder pedals when "WHAM"! The left one went right to the firewall. Experimentation revealed availability of brake only on the left side, but with close attention, the landing was uneventful. Inspection revealed that the torque tube wall had fatigued at the edge of the weld as a result of repetitive localized bending. The repair consisted of rewelding the brake, plus the application of a finger patch on each side. With a little ingenuity and careful measurement, the rudder assembly can be cut from the fuselage and all welding done at the bench. A stub is welded in at the hacksaw cut, and the assembly can then be slipped back into the bearings and secured with 2 each AN3 bolts through the stub. The drawing shows the patch repair. He mentioned this to a fellow

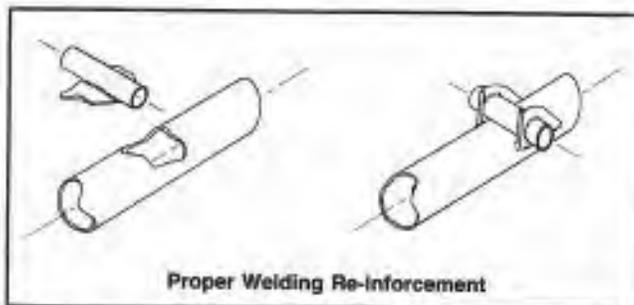
Proper Welding Re-inforcement

The problem was failure of the basic tube structure in localized bending with resultant fatigue immediately adjacent to the weld bead. The obvious cure is the addition of a flanged triangular gusset to each side of the torque tube after welding the cross tube back in place. A further refinement is the incorporation of 2 each ball bearings, which eliminate 100 percent of annoying play at this point. Even a few thousandths clearance in this hinge can result in considerable lash at the stick grip. The drawing on the left shows the broken part and the drawing on the right shows the correction with gussets.

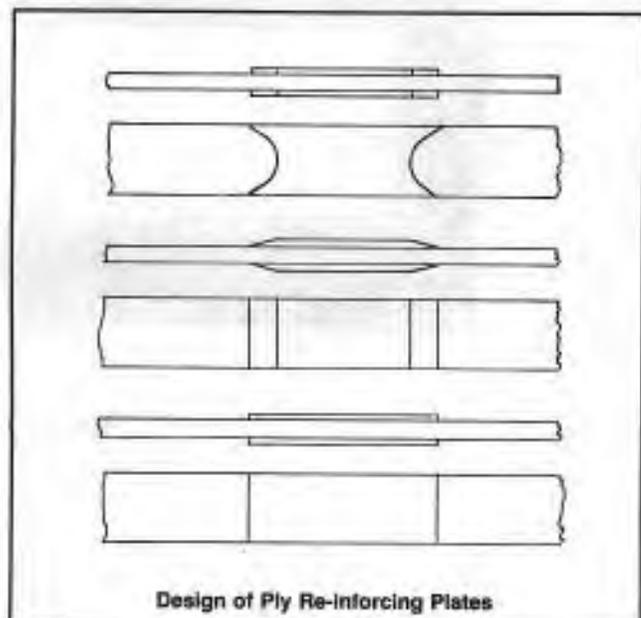
Design of Ply Re-inforcing Plates

The design of reinforcing plates always requires some tapering of material of reinforcing plates near the outer edges to eliminate stress risers. The bottom example in the drawing shows sharp edges that are simply not acceptable that precipitate very high stress areas. The middle one is the usual tapered block and the top one shows another method of rounding cutouts to reduce stress concentration.
