# EAA<sup>®</sup> Technical Counselor News

APRIL/MAY 1990

## Jerry Walker's Falco

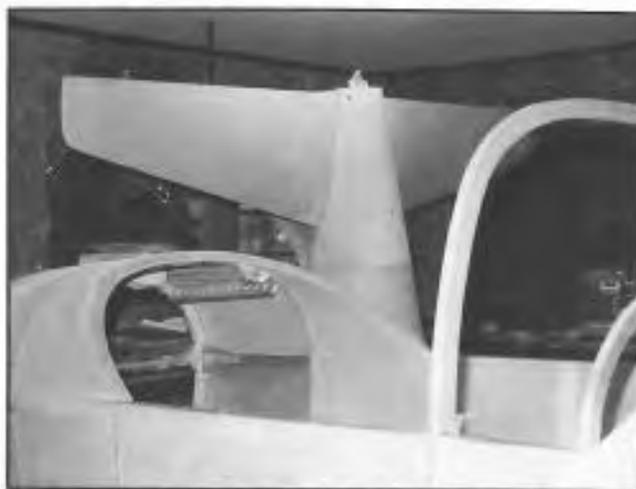
The aircraft won't be flying for a few years because he works only two to three months a year on it, the rest of the time he is out of town. This shot shows the canopy bow.

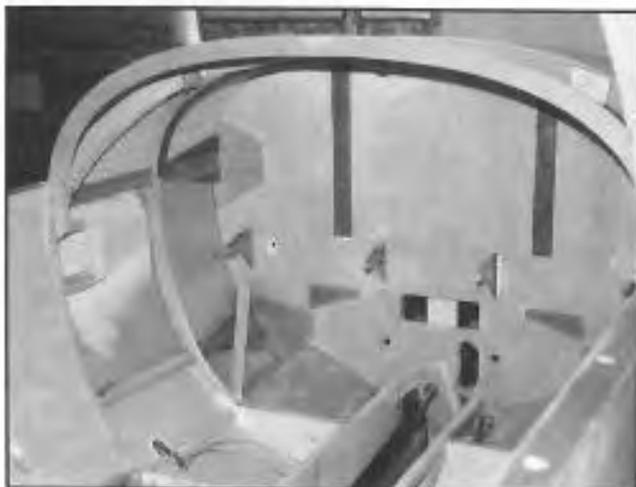
This shows the cockpit interior and some of the nice woodwork that Jerry is doing. Note the wax paper covered strip to the left stapling down the cockpit interior wall to the fuselage station frame.

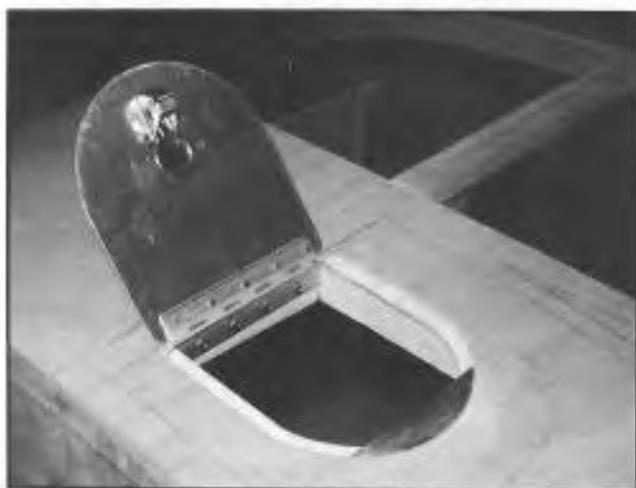
As seen in the picture, Jerry does a great job of woodwork, nice inspection door!

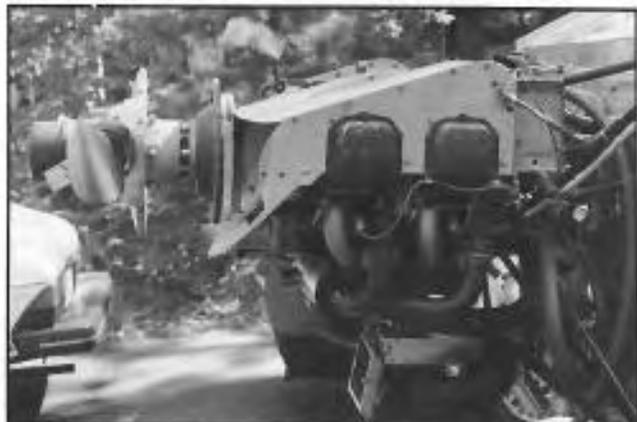
This is a nice shot of the O-320-D1B Lycoming of 160 horsepower with a constant speed prop.

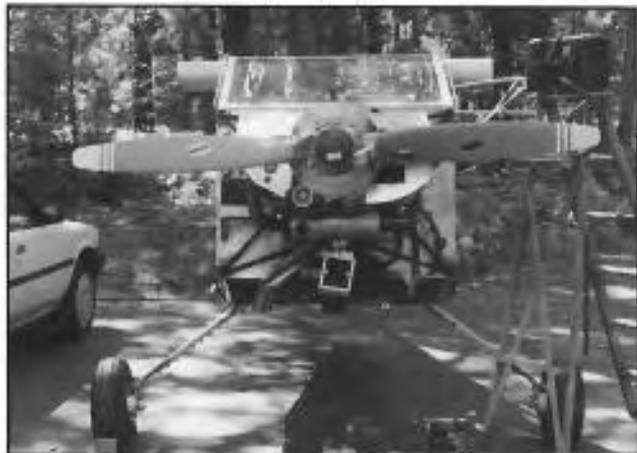
This shows the engine running tests and the makeshift fuel tank.

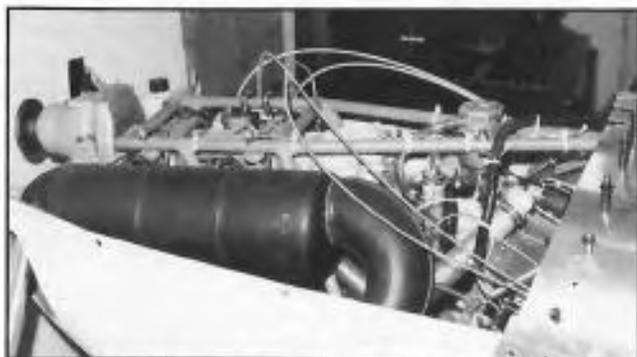
How to hide the muffler on the a Rotec installation. Gear reduction is also visible.

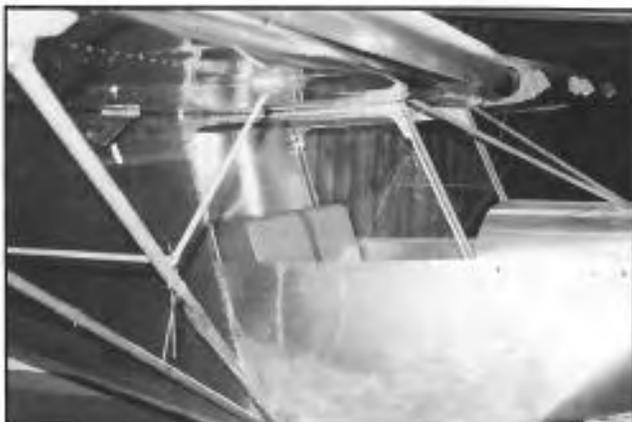
Cabin area shown fairly clearly here and also the leading edge slats.

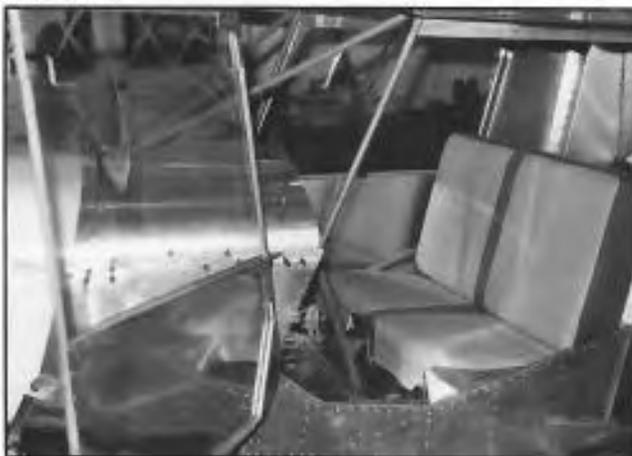
The cockpit area, nice upholstery!

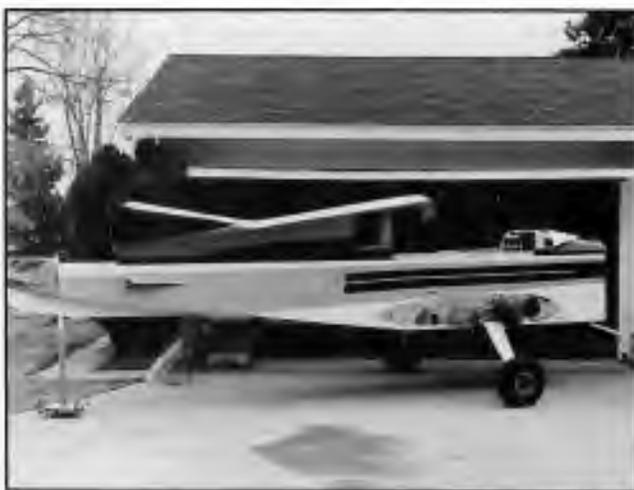
This month's picture shows a completed paint job on the fuselage of my Grumman test bed. It will get a 1/4 inch thick windshield for extra bird-strike protection, and improved noise quietening. The Volvo V-6 will be flight tested after the Buick V-6 files for 200 hours. We are looking forward to Dick's engine on display near the homebuilders headquarters.

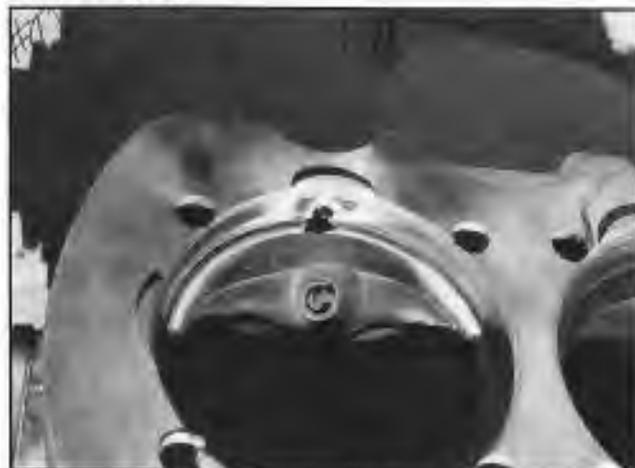
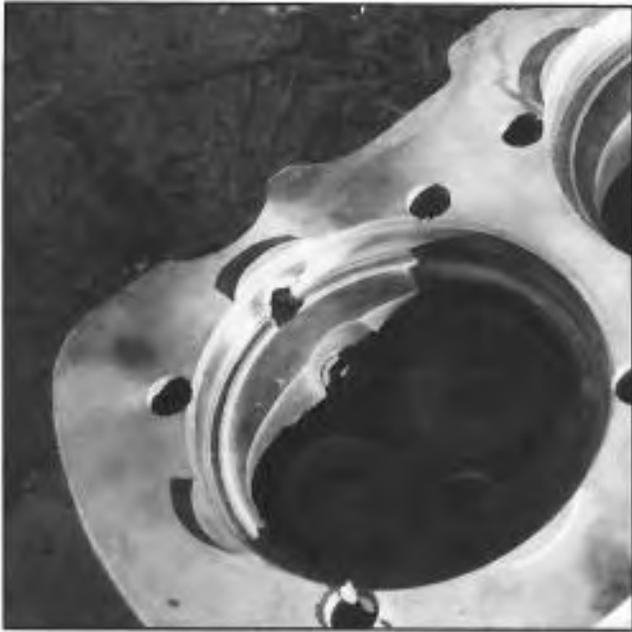
Photos number 1 and 2 show a hole in the head. Very hard to see in photos 1 and 2 is a groove hammered in the head running 90 degrees in each direction from the hole. Looking at it from the side, it is a very sharp edge and the head was on crooked and worked loose. The hole looked like it was cut with a cutting torch.

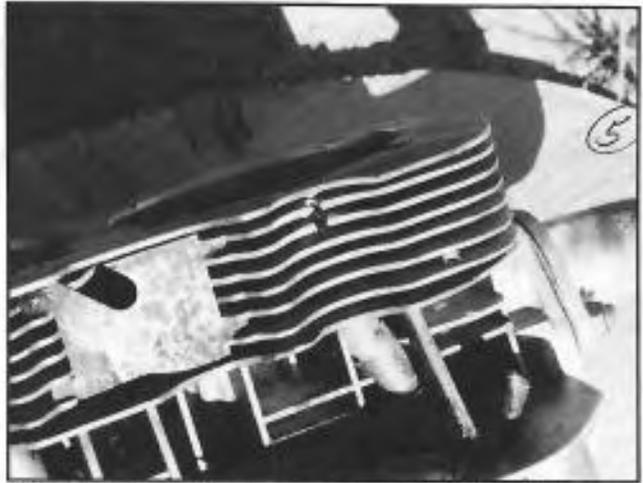
In photo number 5, you can see the external view of the hole that was burned in the head from the hot gases. (All this from not tightening up the head bolts running in the engine and checking it again.)

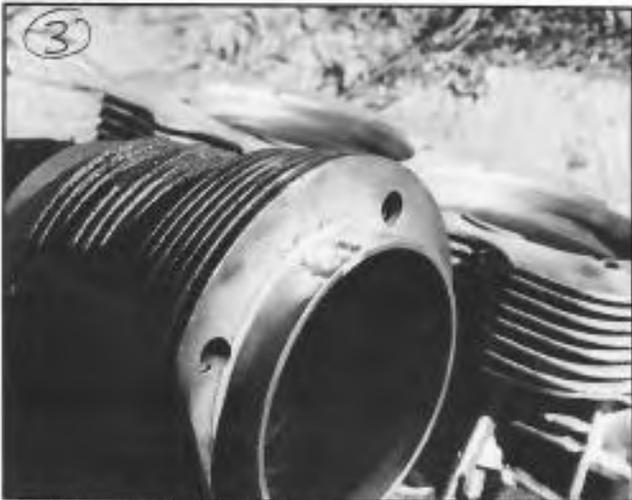
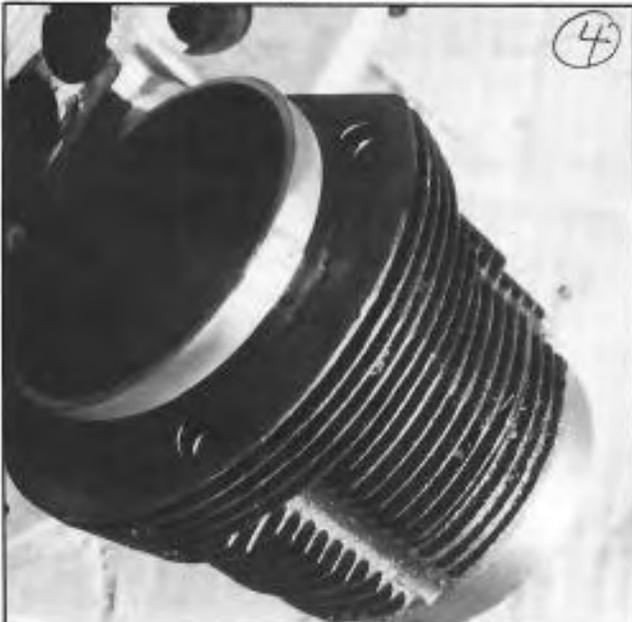
In photo number 3 and 4, you can see the areas where the hot gases bypassed the head, burning a hole in the head and marking the cylinder lip themselves.

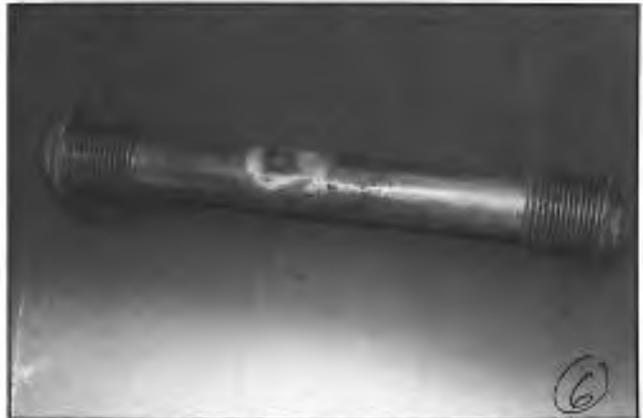
Photo 6, the push rod tube housing also shows evidence of hot gases on its exterior.
