EAA[®] Technical Counselor News

AUGUST/SEPTEMBER 1987

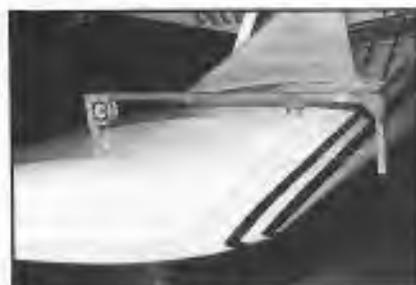
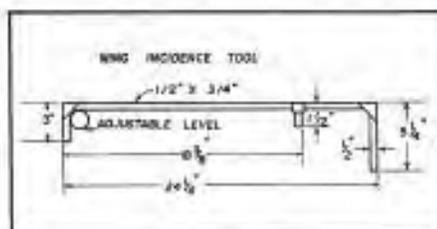
WING INCIDENCE TOOL

With this tool, the incidence along the wing (or wash-in and wash-out along the wing) can be checked to eliminate any twist. The dimensions shown are for either Pitts or Acro Sport I. The tool is useful for any aircraft, but dimensions may need to be changed. The better the level used the more accurate the tool.

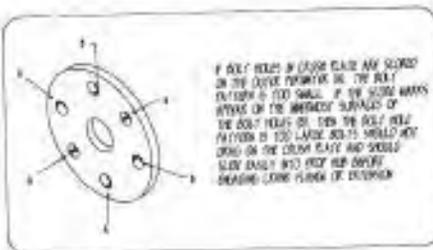
5. While tightening the prop bolts on a Long Ez project, a Technical Counselor encountered a suspiciously high torque reading even though the bolt heads had not yet bottomed. It seems the crush plate obtained from Great American Propeller Co. had a bolt pattern too small in diameter. He drilled out the holes with a .015 inch larger diameter bit and that cured the problem. The Great American Propeller Co.'s Fred Griffiths said that the plates had been supplied by Ken Brock and they thought they had caught all of them and was disturbed that a bad plate had been shipped. A Technical Counselor suggested that "loose prop bolts continue to be the single most frequent cause of non traumatic, mechanical failures in wood props I've examined to date. Torquing the bolts to the appropriate reading is vital to a safe installation. Periodic retorquing of the bolts is mandatory with a wood prop, even with one with the precision and strength of Great American's." Thanks to Art Bianconi.

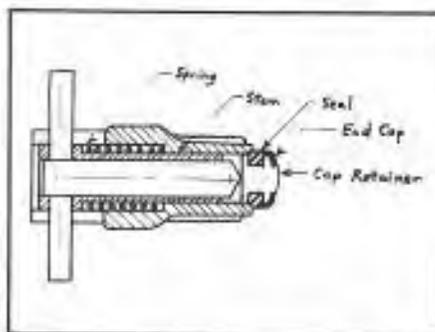
valve body by spring tension if its seal deteriorates to a point where it no longer provides a cushion for the stem end cap. Loss of cushion caused the cap's deformation and/or the shearing of the end cap's rolled metal retainer. Once the end cap has departed the stem and the remaining seal seat material is sheared away, the spring will eject the stem from its valve body allowing fuel to drain freely.

The rate of seal deterioration, which normally occurs after hundreds of valve closings, has been greatly accelerated recently by seal exposure to low lead gasoline. The low lead gasoline softens the seal material thereby increasing its wear rate. The seal material, a nitrile compound, has been found to be the best of the presently available materials for this application. In most instances, a marginal seal can be detected by fuel leakage from around the valve stem, but not in all instances. Because of this inconsistency, the submitter recommends that after the valve has been closed, firmly grasp the stem handles and pull downward. If any downward movement of the stem is felt, remove and inspect the valve assembly prior to flight. CAUTION: When pulling downward on the valve stem, a marginal stem assembly may be pulled from its body and followed by a gush of fuel.

A mechanic advised he has found several leaking valves with "O" rings installed instead of the proper seal. The mechanic requested owners and pilots be advised that installing "O" rings is a no-no and requested the part number for the proper seals be published.

CCA-1550 - Seal Part Number
1269
CCA-1600 - Seal Part Number
1319
