# EAA<sup>®</sup> Technical Counselor News

FEBRUARY/MARCH 1989

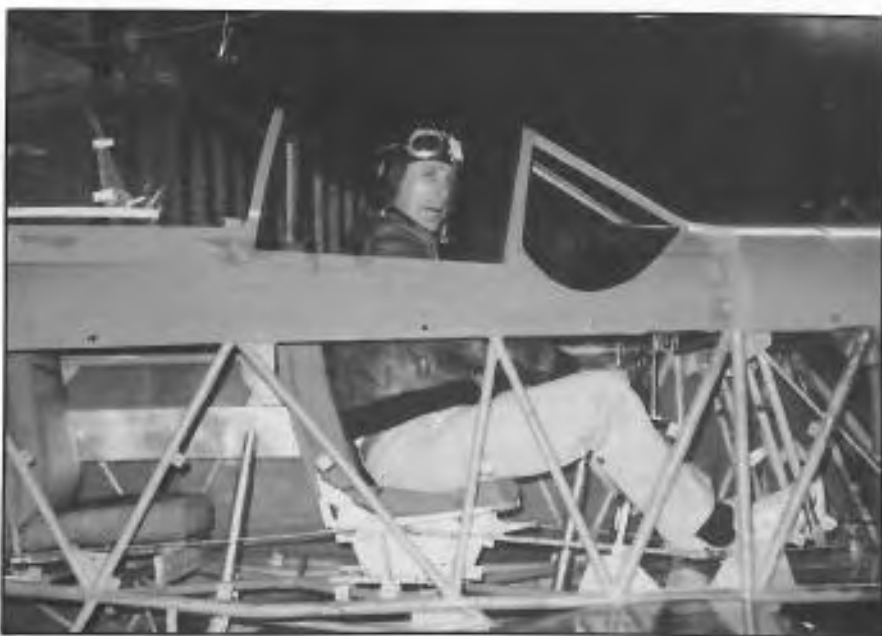
Technical Counselor Bud Shanks reports on Tom Leonhardt and Dick Buck's 3/4 scale Jurca P-51. One of the builders, we don't know which one, shows how the cockpit sits.

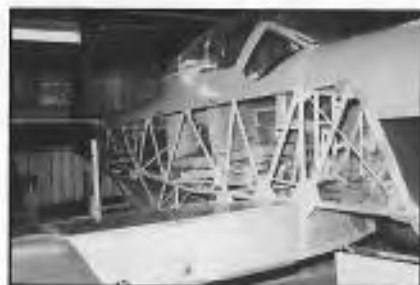
Fuselage from the side, first class workmanship. Tom says it is about 70 per cent complete — a ten year project.

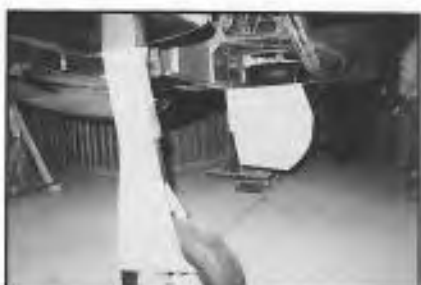
This other wing shot in the landing gear area shows one wheel down and one up.

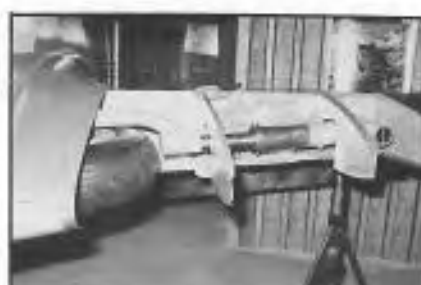
This close-up shot of the landing gear shows it retracted.

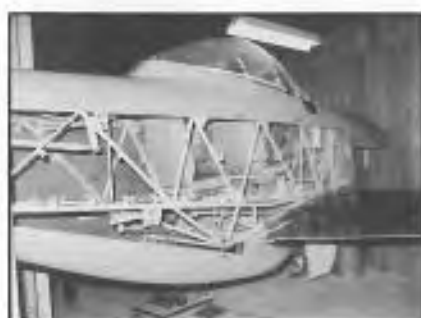
Right. This shot shows the plywood wing with the aluminum spars in the landing gear area and fiberglass wing skin.

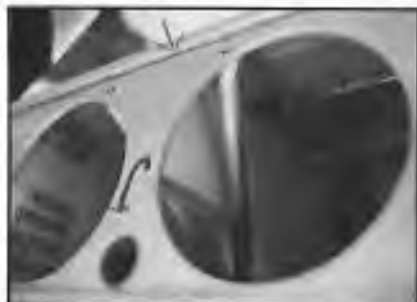
The wingspar on the Cloud Dancer is a patented design made from extruded aluminum. Its symmetrical when made and then cut diagonally, vertically down the spar to create two exact spars. The thicker width is placed at the wing attach point. The design incorporates a built in lip that the tip skin clips into securely. (See arrow) Mary, by the way, is our first and only female Technical Counselor.

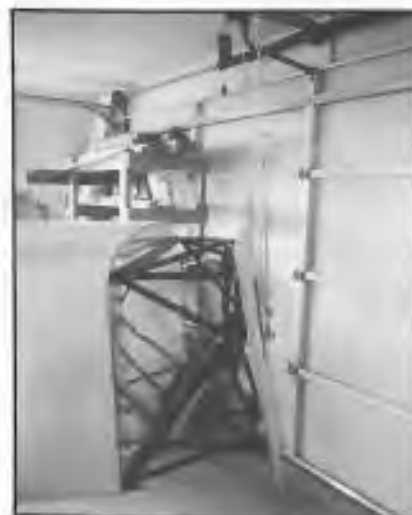
Wayne is building his fuselage with the front of the fuselage supported by a chain from the ceiling attached to the engine mount and the rear supported by a padded saw horse, this allows all the fuselage seams to be glassed in a horizontal position by simply turning the plane upside down. Wayne also made the instrument panel removable for faster component access when completed.

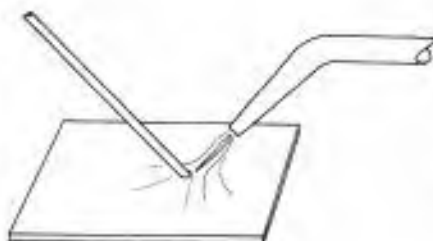
Light Torch: make blue flame 1 inch long. Hold flame 90 degrees to work with the tip of the Blue Flame touching the crack in the metal. When metal looks sweaty or moist, place tip 45° to the work and place tip 3/8 to 1/2 inch to crack in metal. Add Stainless Steel Rod No. 308, No. 316 or No. 305 of 1/16 inch to the Blue Flame. Keep welding rod and the melted metal in the Blue Flame.

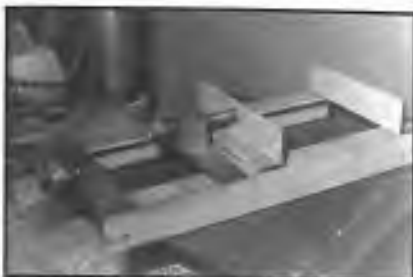
This holding fixture has an aft movable jaw. Note there is an additional brace under the aft movable jaw to keep it centered side to side. The threaded rod has pins that can be placed on the bed to vary the position for the holding fixture.

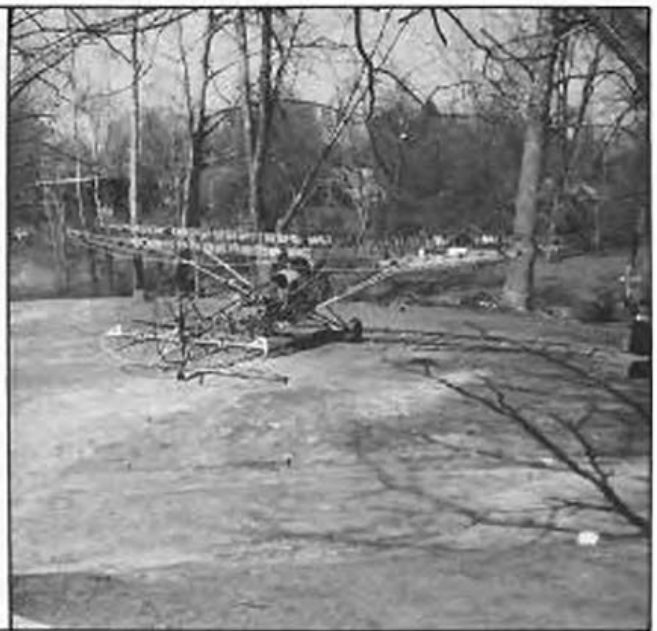
This photo shows the elliptical wing as the project is being rebuilt. It uses a Vee-5 of 65 hp.
