EAA TECHNICAL COUNSELOR NEWS

JUNE/JULY 1986

A TECHNICAL COUNSELOR'S PERSONAL PROJECT

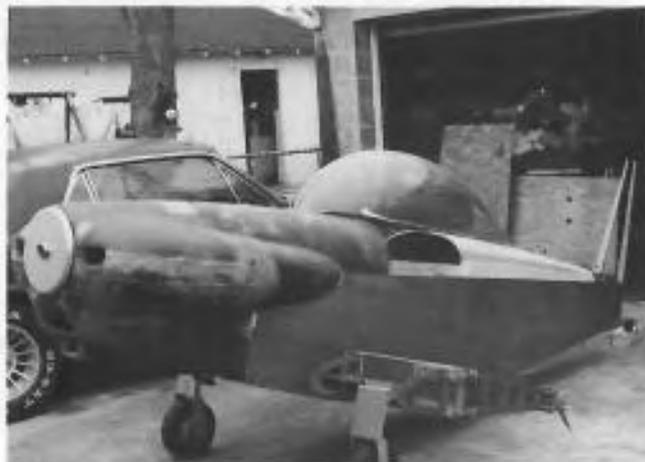
TECHNICAL COUNSELOR GENE DARST'S PERSONAL PROJECT is a KR-1, here on the gear and out of the garage.

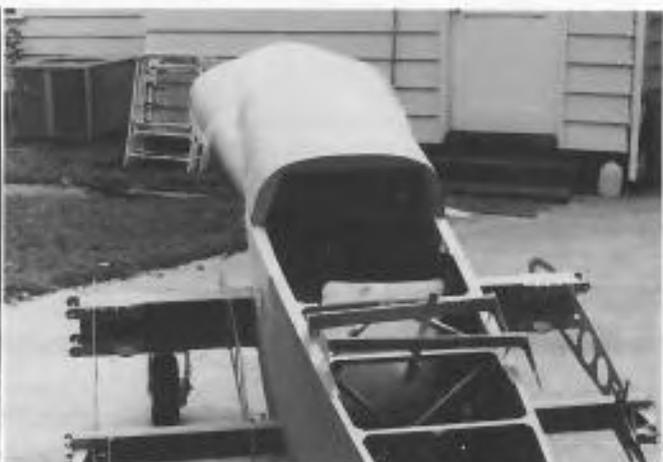
This shows the cockpit area, and some details of the center spars on the KR-1.

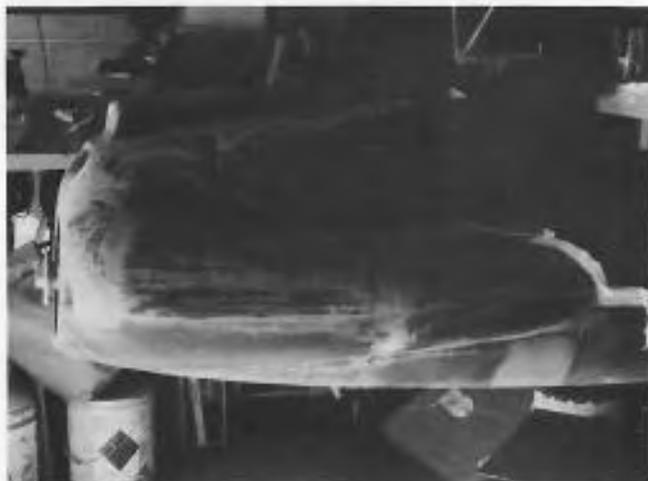
The cowling is upside down so that Gene can work on the oil cooler scoop on the bottom side. Gene has got nice lines on the cowling.

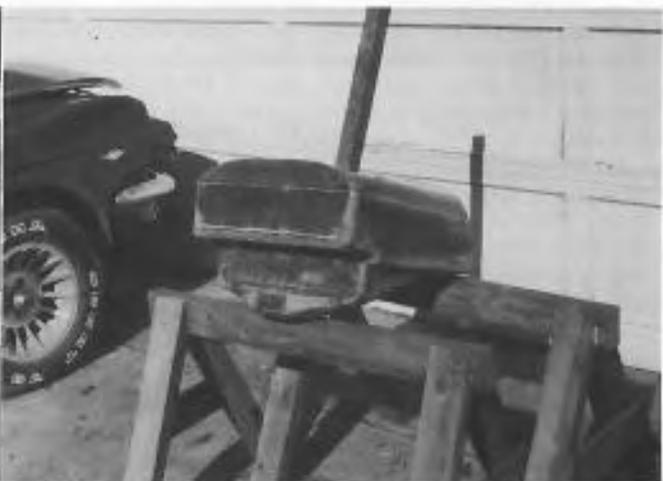
The eight gallon fiberglass tank is complete and ready to install.
