Technical Counselor News

MAY • JUNE • JULY • AUGUST

Chapter 563 Annual Project Tour

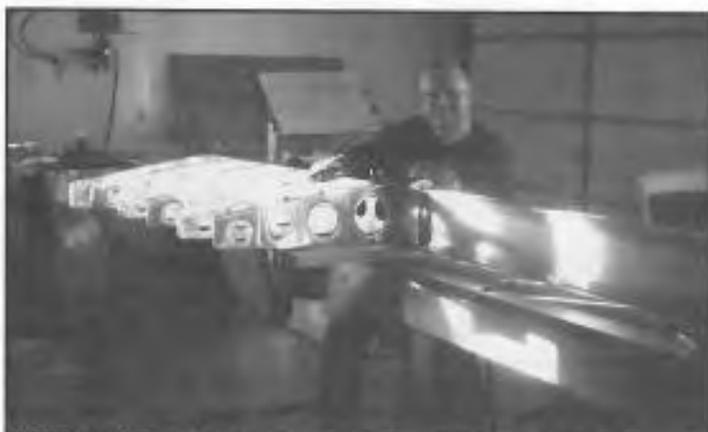
Dick Guenther's RV-6A

Dick Guenther, Technical Counselor from Prescott Valley, Arizona is working on his RV-6A wing.

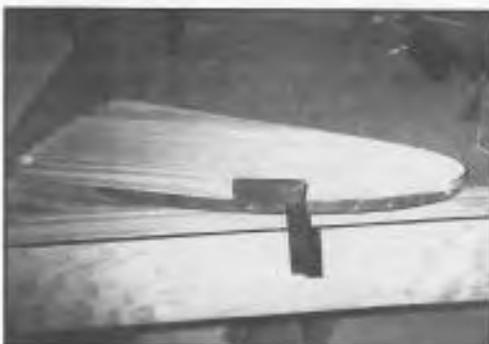
Making a pattern to fit inside a hydroform rib and marking the rivet placement with a small square and a pilot felt tip is much faster than using a ruler on each rib. This gives you the rivet interval and you can flute in between rivets to straighten the rib.

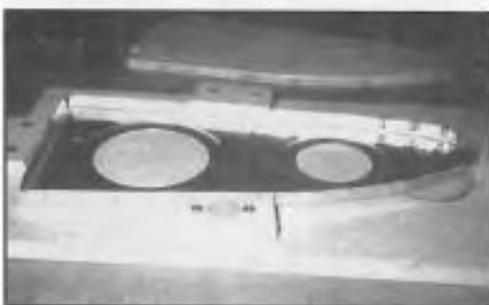
The rib holding board is clamped to the drill press table and the member is clamped to the board before the reinforcement holes are cut out. A hole saw or a fly cutter is used. He relieved all of his wing ribs in less than four hours.

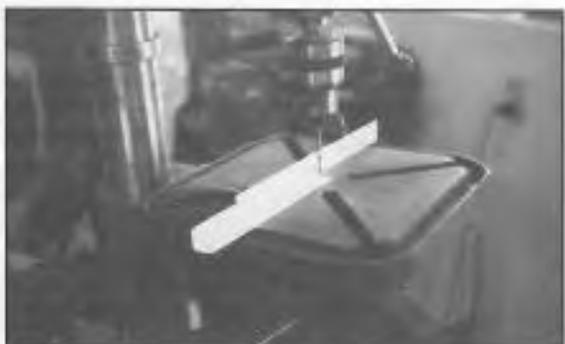
The fence clamped to a drill press table enables you to drill holes parallel to a given edge to make a good looking line of rivets with a proper edge spacing.

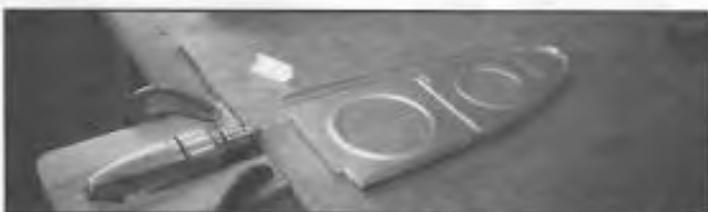
Use the jig and clamping the drill enables you to drill holes in line in the middle of the web. The auxiliary table top is shimmed with the bit on the center of the web.

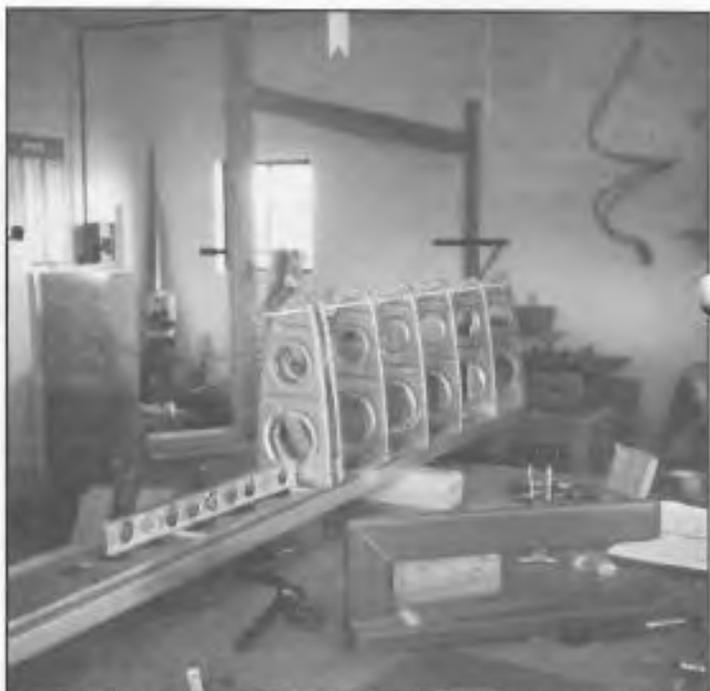
Threaded bar really holds the ribs in alignment for blind drilling. Dick has the following suggestions on AN rivets:

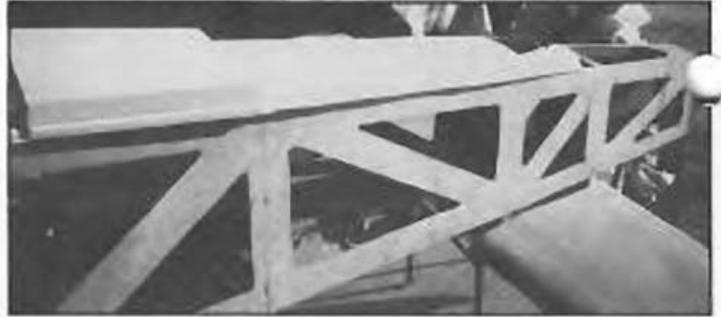
Shows some of the nice detail work in the area of the tail. Over a period of six years he built most of the parts on the fuselage.

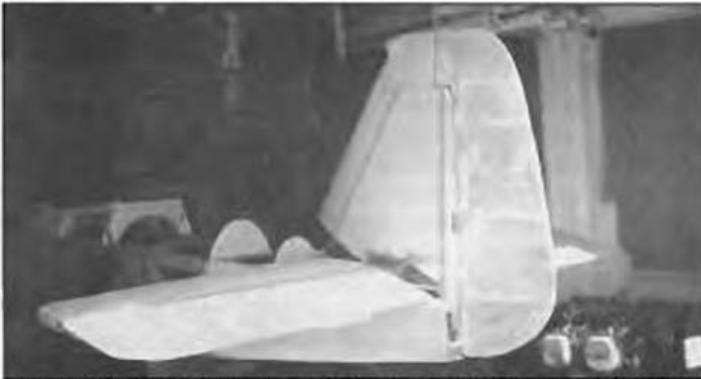
The unmistakable lines of a Focke Wulf 190 tail. John Barcus reports the wood, foam and general workmanship is near perfect.

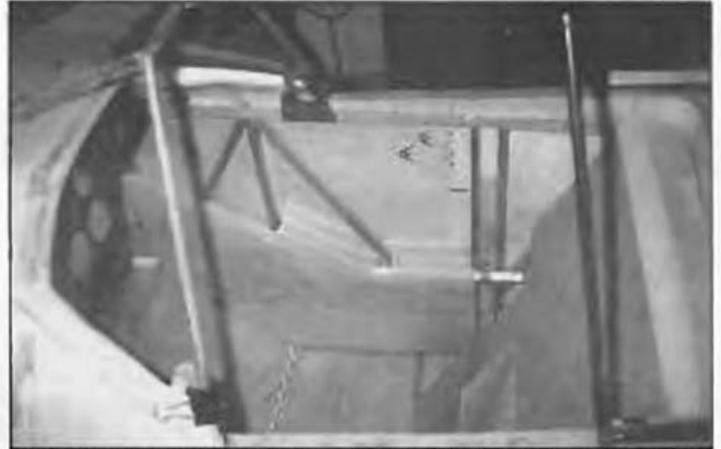
The cockpit shows some nice fiberglass work. The aircraft is being built in a small, but well organized garage. Bob is also the Mayor of the town of Ocala, Iowa!
