EAA Technical Counselor News

OCTOBER/NOVEMBER 1988

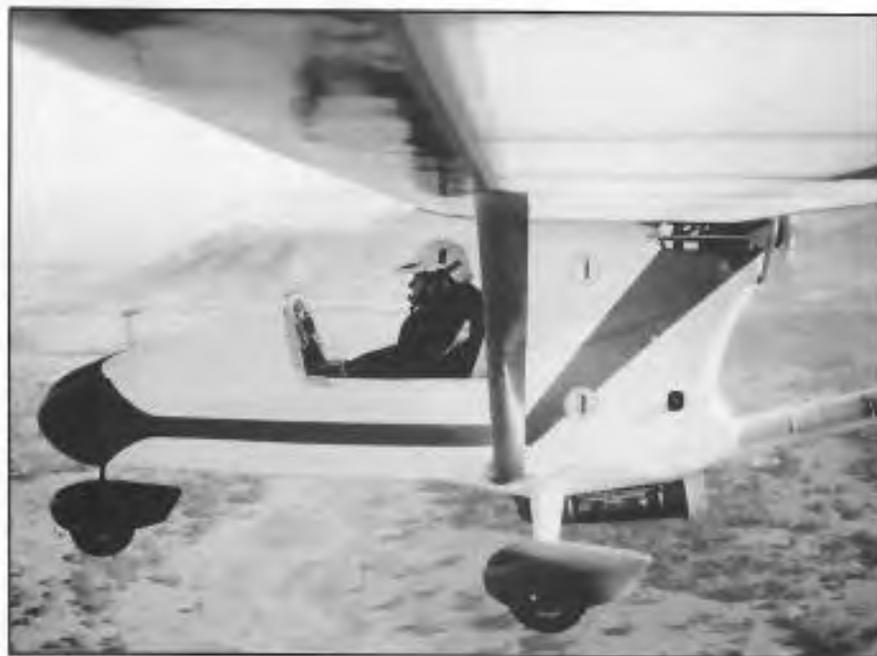
MALCOLM DARBY'S RESURGAM

This aircraft is an ultralight built in 1983 by EAAer Malcolm Darby of Armidale, New South Wales, Australia. It has almost two hundred hours of flight time, uses a four cylinder Konig radial engine, has a top speed of about 65 mph and 240 pound empty weight. It was designed by Gordon Bedson of that country.

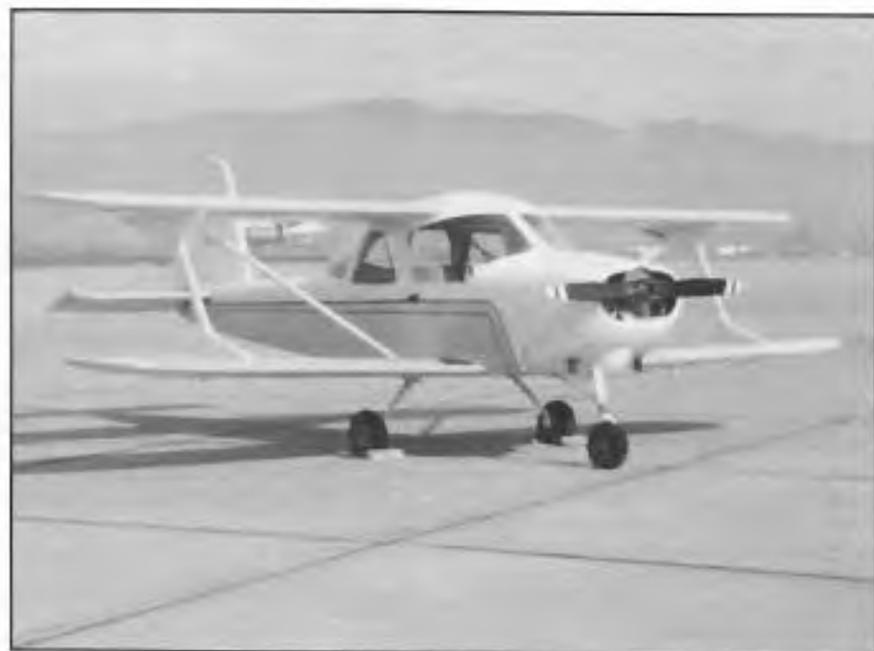
FRANK WOZNIAK'S "DOUBLE EAGLE"

This is a two place, side by side negative Stagger biplane built of wood, fabric, and fiberglass. The engine is a Lycoming O-320 of 150 HP. Wing span is 24 feet, the length is 18 feet 8 inches. The wing area is 157.5 square feet and the weight is 1075 empty, gross weight 1500 pounds. The aircraft was built over a period of 13 years by Frank. The structure has all the provisions for a retractable landing gear; everything is there except the driving mechanism and the doors. He decided to bolt the gears on in the down position in the interest of getting it in the air sooner. Frank hails from La Mesa, California.

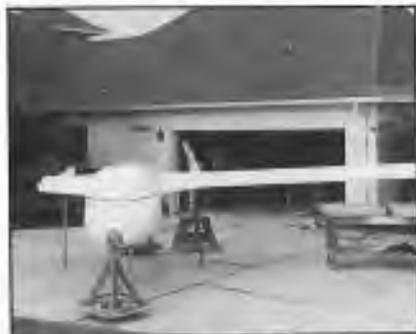
This shows the aircraft with half the wing on.

Enclosed are some photos of the molds Gary has finished to date. He hopes to be forming parts very shortly. These molds are suitable for Thermoset or High Temperature materials that kick at about 250 degrees F (you know - The Lancair Method). He's been working with a supplier on a resin system which is more practical, "You see — the secret is how to wet-out the gel, keep the weight ratio in balance, keep the Thix up, keep it drapable, extend the pot life, store at B stage, increase the compressive strengths, and add to the toughness — there's nothing to it (ha ha) — I'll keep you posted."

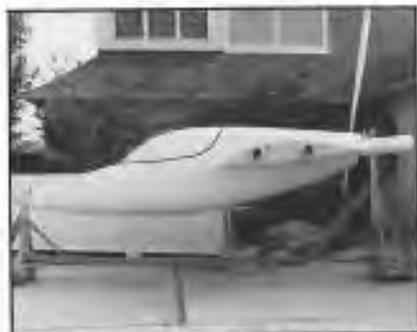
A nice jig Gary has made which allows the fuselage to be rotated.

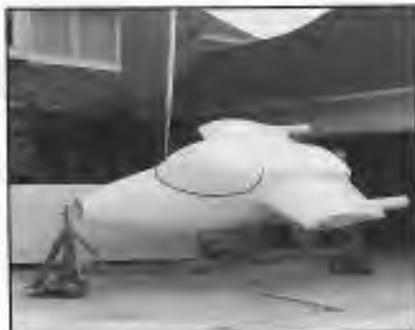
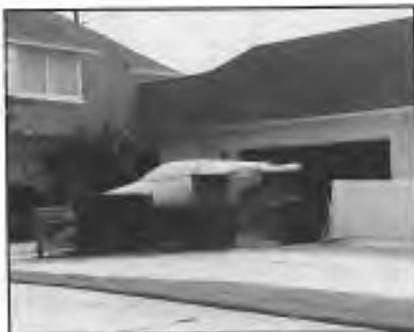
This photo shows the molds made from the male mold. The climate of Houston where Gary lives is excellent for fiberglass work.

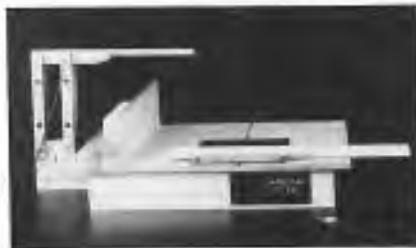
A foam cutter set up much like a jigsaw is available from Martin Carbone, 2519 Bath Street, Santa Barbara, California 93105, telephone (805) 682-0465.

Your editor, Ben Owen, built one similar to this that he has used for years. This particular cutter has guides and looks like it is accurately made.

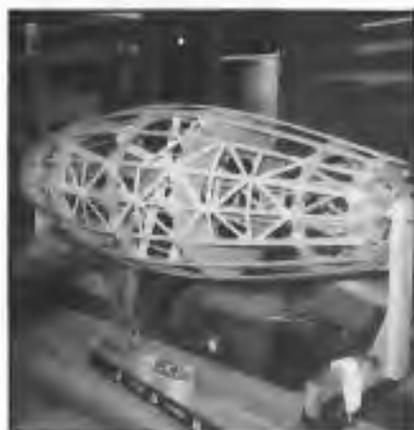
AN ARCHITECT'S DESIGN

Architect Ron Petralito of Baltimore, Maryland sent down this photo of his design for an infinitely adjustable armature for rotating a fuselage during construction. As you can see, it is made out of standard 1 inch I.D. pipe, two 4 inch U-clamps and two wing nuts. With this design, it is possible to tighten the wing nuts by hand to create the desired resistance to rotation, including total immobility. If the pipe is threaded at both ends, a cap can be used to keep it from sliding out of the jig.

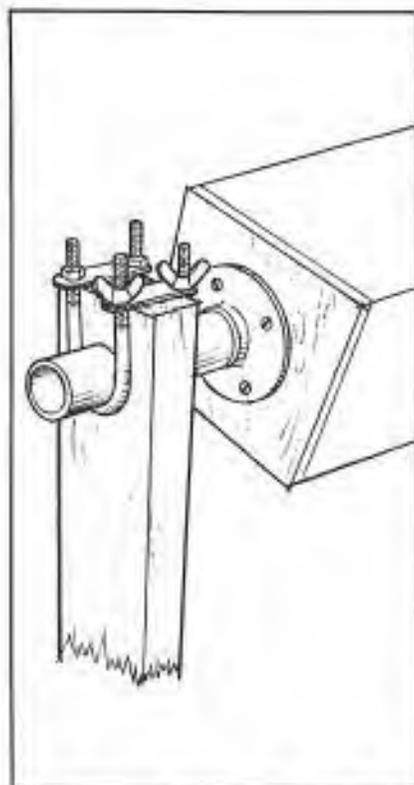
This drawing shows the U-bolts and wing nuts at the ends.

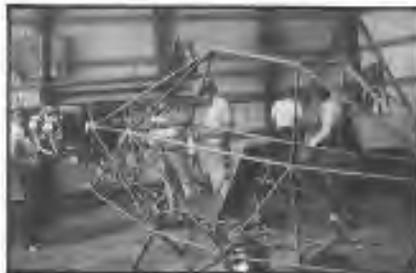
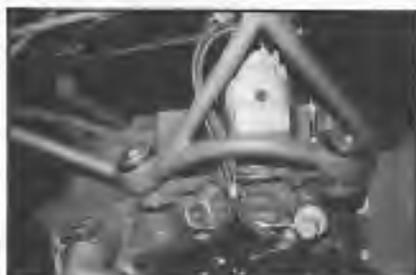
VICE PRESIDENT'S CUBY SPORT TRAINER

Technical Counselor Bob Johnson reports that Chapter 680 Vice President's Sport Trainer is an excellent example of good welding. Bob says "this whole project is what I would call near perfect. This is his first try at building anything!"

Particularly look at the one photo of the motor mount — notice the class of welding.

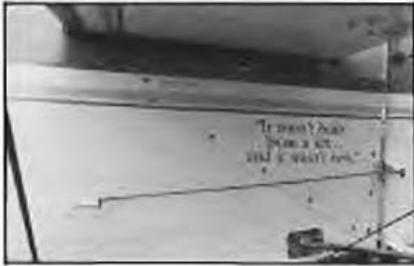
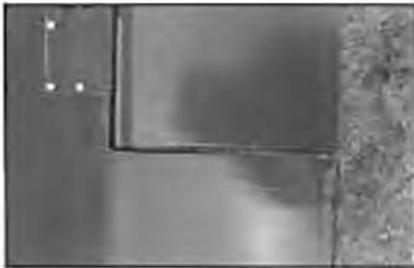
A common error often seen on biplane ailerons is that the root ribs are simply not built strong enough to resist the pull of the fabric as it tightens over the years. This inboard rib must be solidly built.
