EAA[®] Technical Counselor News

September/October/November 1990

Bob Humbert's Pietenpol

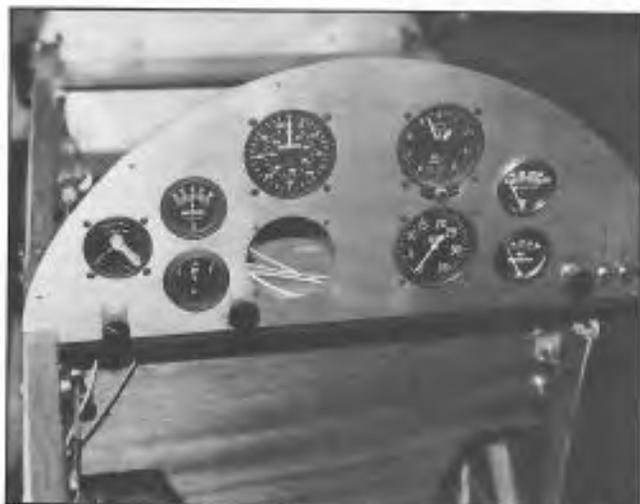
This shows the Humbert Pietenpol instrument panel and the very meticulous work being done.

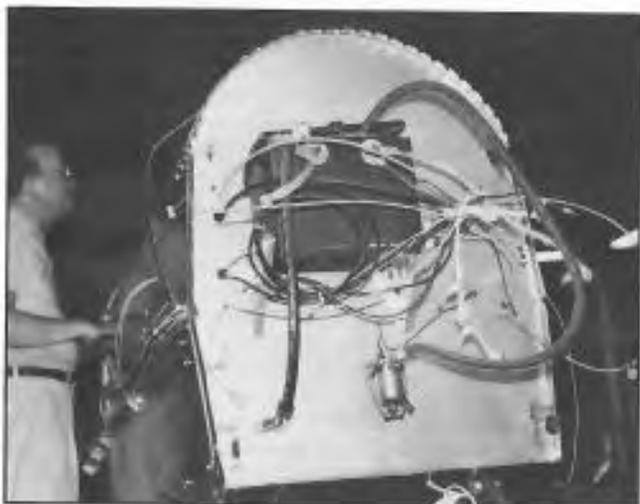
This shows the detail in the area of the firewall, gascolator and the box on the firewall.

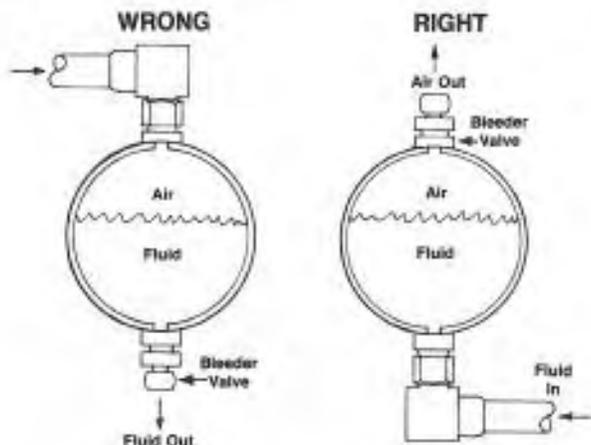
NEIL SIDERS COMMENTS ON THE ARTICLE "WHEELS & BRAKING" MARCH '89, CRAFTSMAN'S CORNER, PAGE 42

In looking over the article, I discovered a point that you may have overlooked. The drawing for the gravity method of brake bleeding is incorrect. When bleeding from the top down, it becomes necessary in some cases to remove the wheel cylinder and hold it with the bleeder valve at the top. If the bleeder valve is on the bottom, air is trapped in the wheel cylinder and all you do is pump fluid through the system. Just remember to put some sort of spacer between the pads to make up for the rotor.

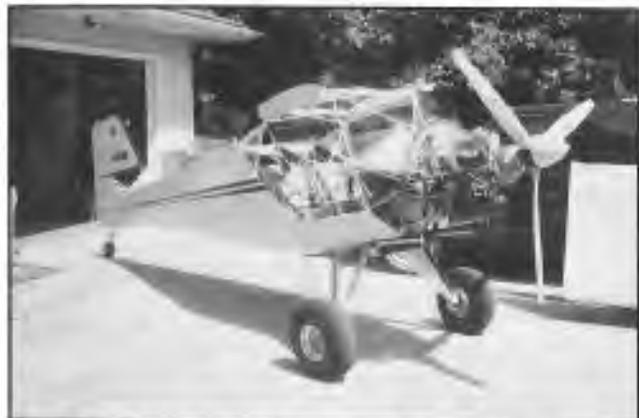
Joe McKinstry's Kitfox

Kitfox by builder Joe McKinstry of Belleville, Illinois. The aircraft is complete with the exception of the counter balance weight on the flaperons. Photo by Technical Counselor Wil Krebel of Pierron.

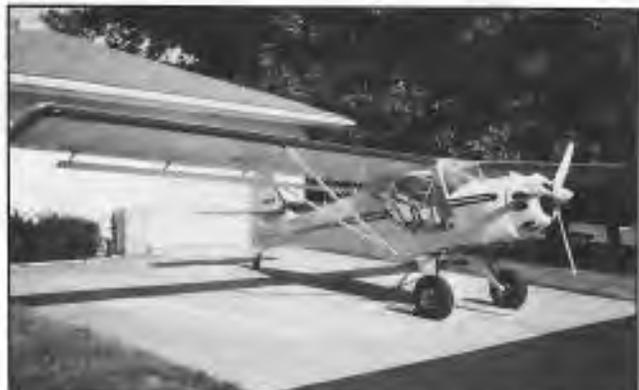
McKinstry's Kitfox uncovered showing the engine and the 3 blade propeller.

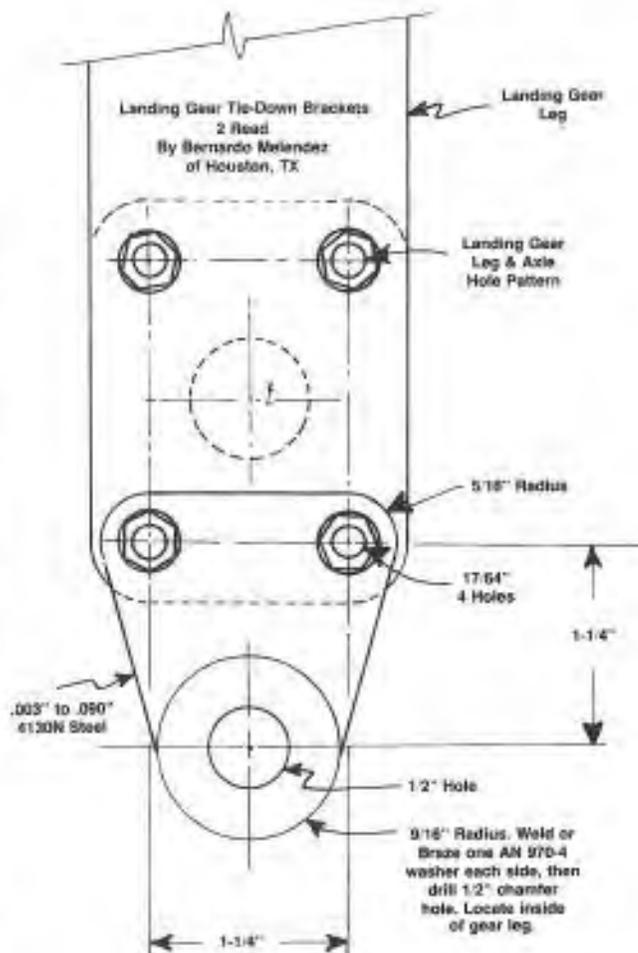
Suggestion from the Soneral Newsletter submitted by Gordon Timmins. Our very first newsletter back in April 1982, included a building tip describing a wing tip tie down bracket installed outboard of STA 107. This necessitated that the spar be left an inch or so longer, to allow the bracket to be attached. If you cut the spar off at STA 107, as per the plans, you couldn't install this bracket.

Here is a drawing of another bracket that can be installed regardless of the spar length.

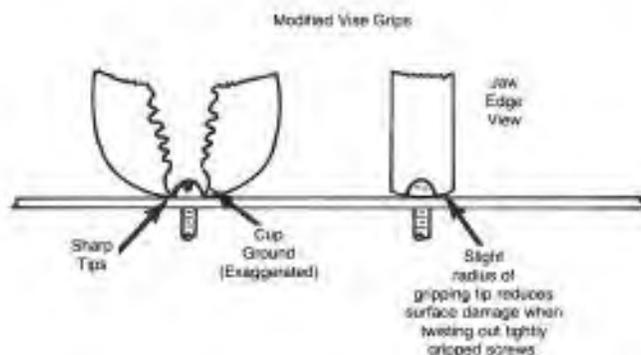
Simply, a very small cup is ground in the tip of the jaws of the Vise-Grips, which allows the jaws to easily and tightly grip the screw to provide a superior grab in removing the screw. By grinding the jaw tips so they have a sharp edge and slight concave bevel, they will actually "bite into" the edge of the screw, and under its edge.

Cautions are to make the grinding just barely enough to give the jaw edge a wedging action that will bite into the screw, rather than sliding off it the way a flat surface jaw will do, and to radius the outside edge of the sharp jaw slightly so that material damage does not occur as the screw is loosened. If the cup grind is too radical, then the jaws will dig deeply under the screw, with resultant sheet metal surface damage. Likewise, if the tip is not radius-ground, then the edges of the jaws will tend to severely scratch the surface metal as the screw is twisted out.

We want to just barely grip the screw tightly, without the jaw tips wedging themselves under the screw edge and damaging the sheet metal surface beneath the screw as it is loosened.

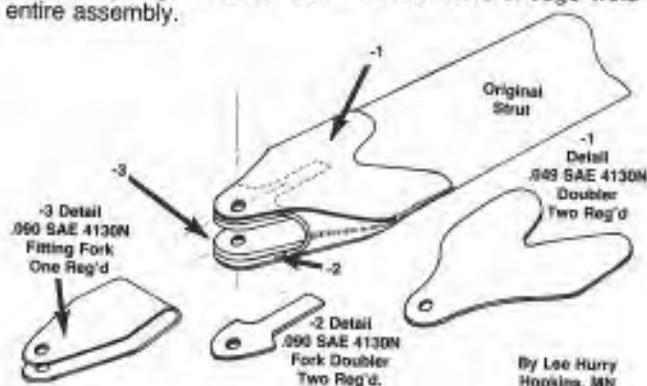
ALTERNATE FOR PIPER STRUT FORK BOLTS

Remove original barrel & clevis end. slot strut in plane of major diameter to receive -3 fork. Weld -2 fork doubler to strut along original barrel slot. Fit -1 doublers & edge weld entire assembly.

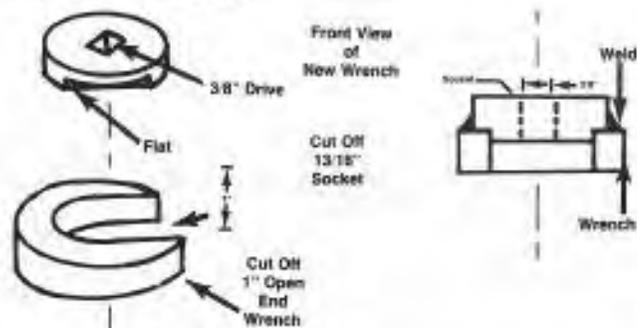
OIL SCREENS

Ever since I began changing oil in C85-0200 powered Casstuts, I've wished for a better oil screen wrench. I always used a 1" open end Craftsman and wrestled with the various angles and wrench turnovers to get the screen out. It seemed that I was forever maneuvering to avoid the motor mounts, oil tank (I have used an aluminum tank mounted to the firewall), or instrumentation (CHT leads, tach cable, etc.). It finally occurred to me that if I could find a 1", 4-sided socket with a 3/8" drive that this task would be much easier. Since none were commercially available (to my knowledge) I cannibalized a socket and wrench and welded them together. I cut off the cheapest 3/8" drive socket I could find so that only the drive portion remained, ground 2 flats 1" apart halfway up this piece, then welded this stub drive centered on the end of the 1" wrench (and of course cut off the wrench handle). This worked great!

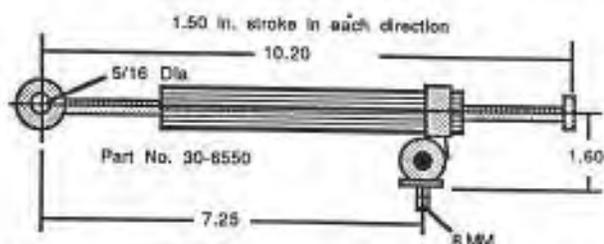
Steering Oil Damper Part No. 30-6550.

From Martin Hollmann's newsletter, Aircraft Designs, Aug./Sept. 1990. Found a nose wheel shimmy damper for his NOVA amateur built, available at \$45 from K & L Supply Company in Santa Clara, California. Telephone number 1-800-727-6767. Below are the damper dimensions in inches.

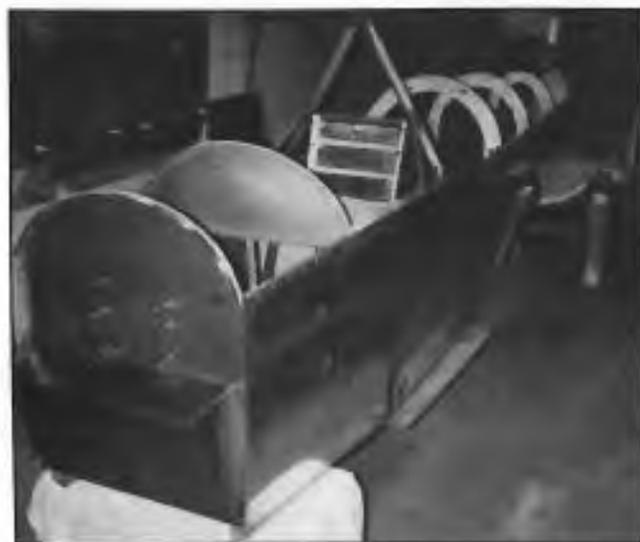
Technical Counselor, Jack Blackwell took this nice picture of builder Robert Pratt. His partner is Ted Martin from St. Louis, Missouri. Both men are experienced aircraft company employees (retired) and expect to have the aircraft completed very shortly. The photo below shows some detail in the way of the Firewall.

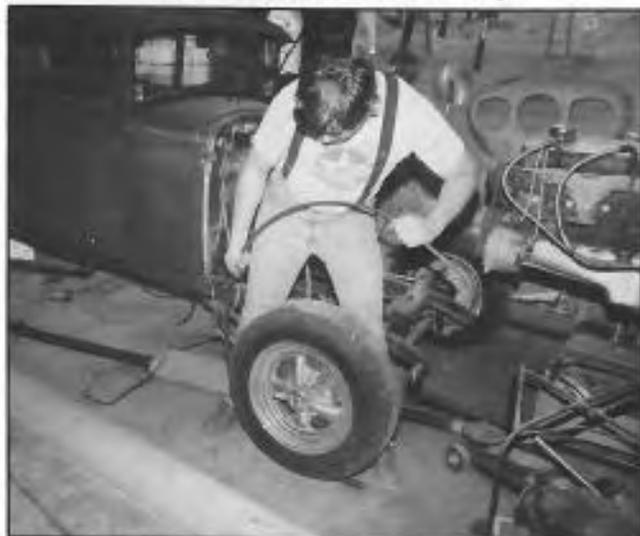
Neil Sidders — a tire makes a great bending tool.

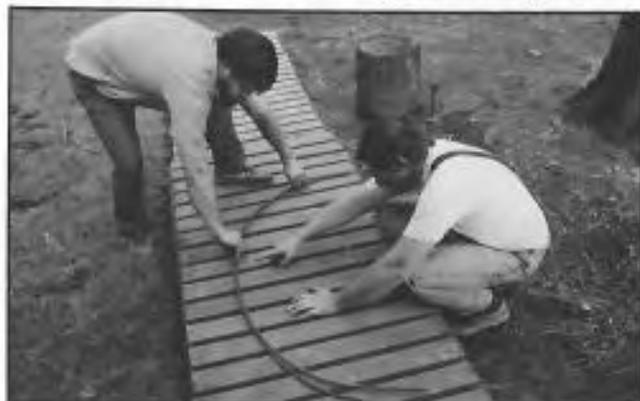
Photo 5 shows the secondary or final form die located under Neil's right elbow. This is commonly called a knee. The tubes are compared on a suitable die table then tweaked until they match. That's Bruce Owens with the beard.

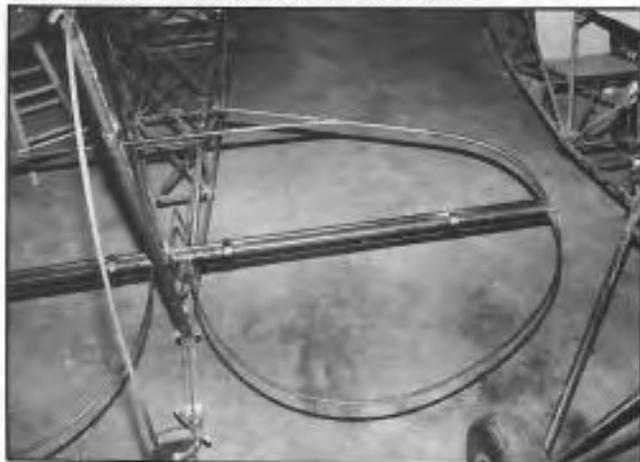
Photo 6 shows the restyled tail section which is more in line with the shape of the vertical fin and rudder. Neil feels home-building gives a person the opportunity to display his or her styling ideas in a way no other hobby or sport can. He loves it!

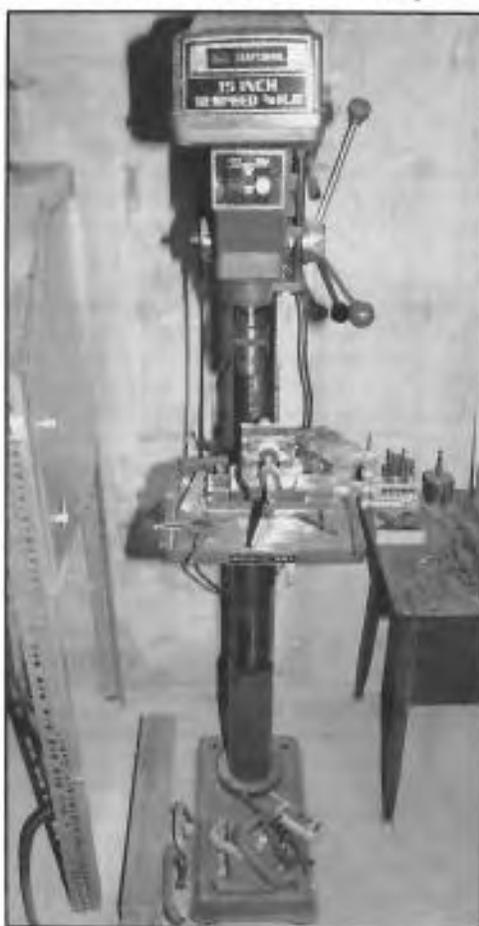
A floor mounted drill press is not a necessity but is very convenient if you decide to drill the spars after putting the wing together. If you have a table mounted model, don't rush out and buy a floor model but it does work well on the wings.

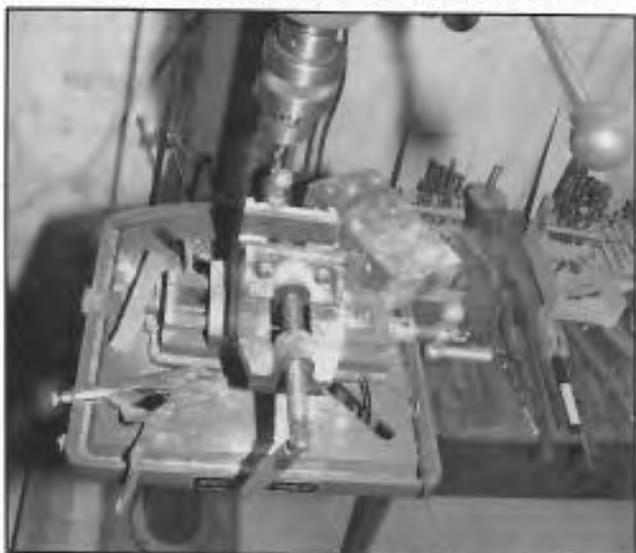
An almost essential item for safety is a hold down for the drill table to keep the parts from moving around, particularly when working with metal.

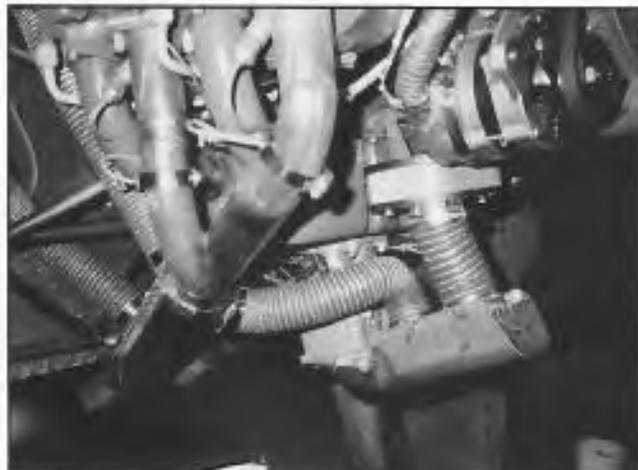
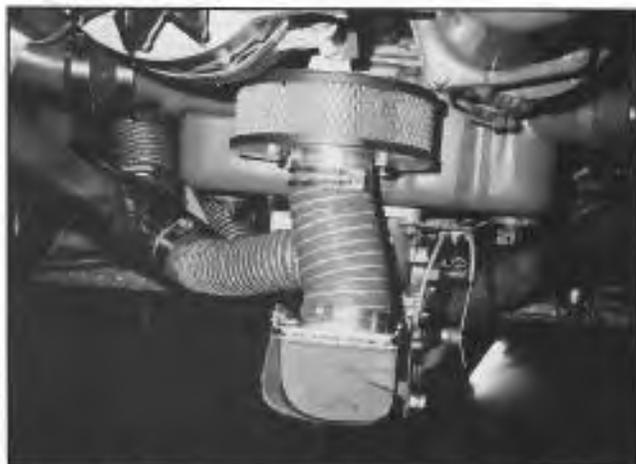
Jerry Malone's RV-6

This shows the box, hose attach and air filter. You can use either direct ram air, filtered air or carburetor heat. Also note the nice heat muff in the attached cabin heat tubes. You can also see the probes he made for the EGT. Also note the cooling duct to the alternator.

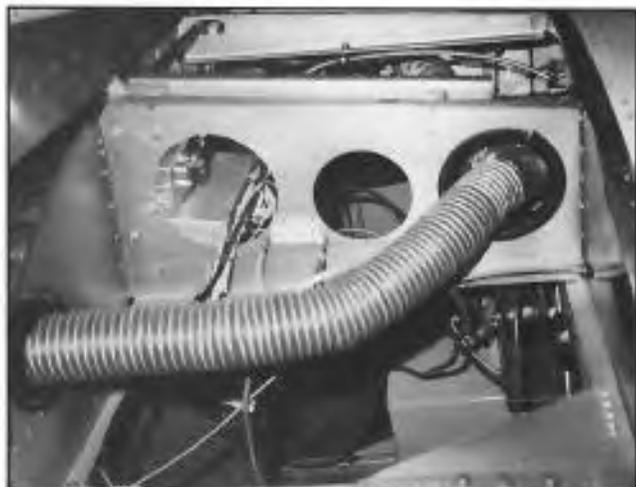
Shows the front view of the air box and control cables for flaps controlling the air flow. The filter is from a John Deere garden tractor.

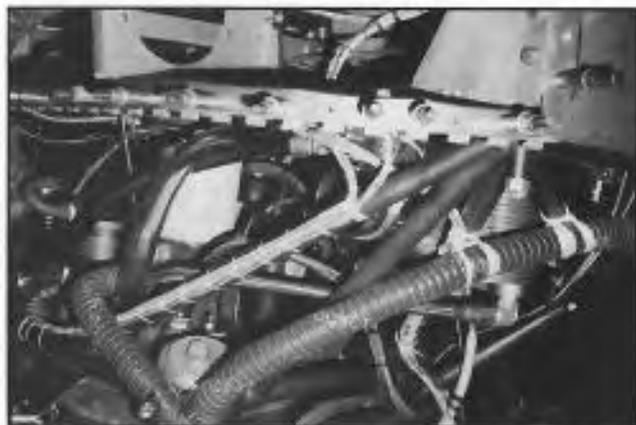
Shows the ducting for cabin air.

Shows the cooling ducts going to the gascolator and fuel pump. He is well aware of the vapor lock I suffered and is trying to avoid it. He has 180 hp Lycoming with a constant speed propeller, yet to be installed is the duct safety pipe to the oil cooler. Photographs by Alex Sloan, Technical Counselor of Florence, Alabama.

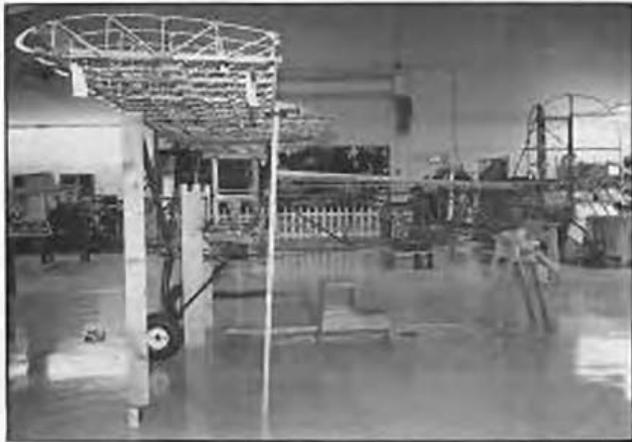
The aircraft is set up with the top longerons perfectly level, using sawhorses, lumber and clamps as shown.

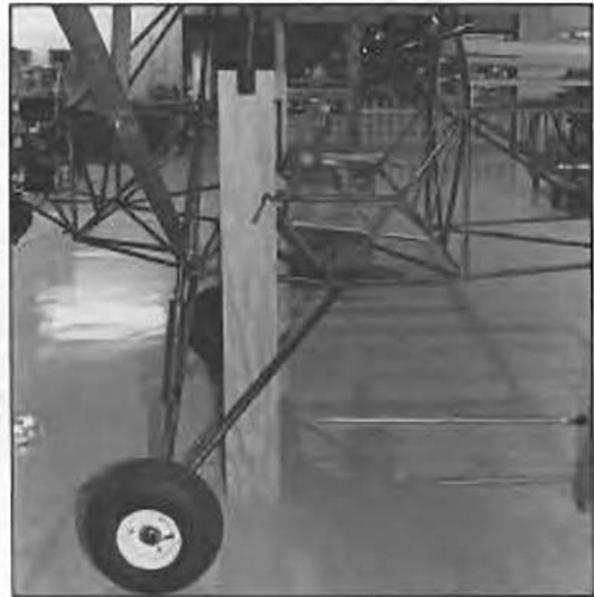
The side is kept from deflecting by being clamped to the floor to keep the front level so the tires will not deflect.
